# Preliminary Engineering Report

## Wastewater System Improvements

### Village of Jemez Springs, New Mexico

February 2, 2024

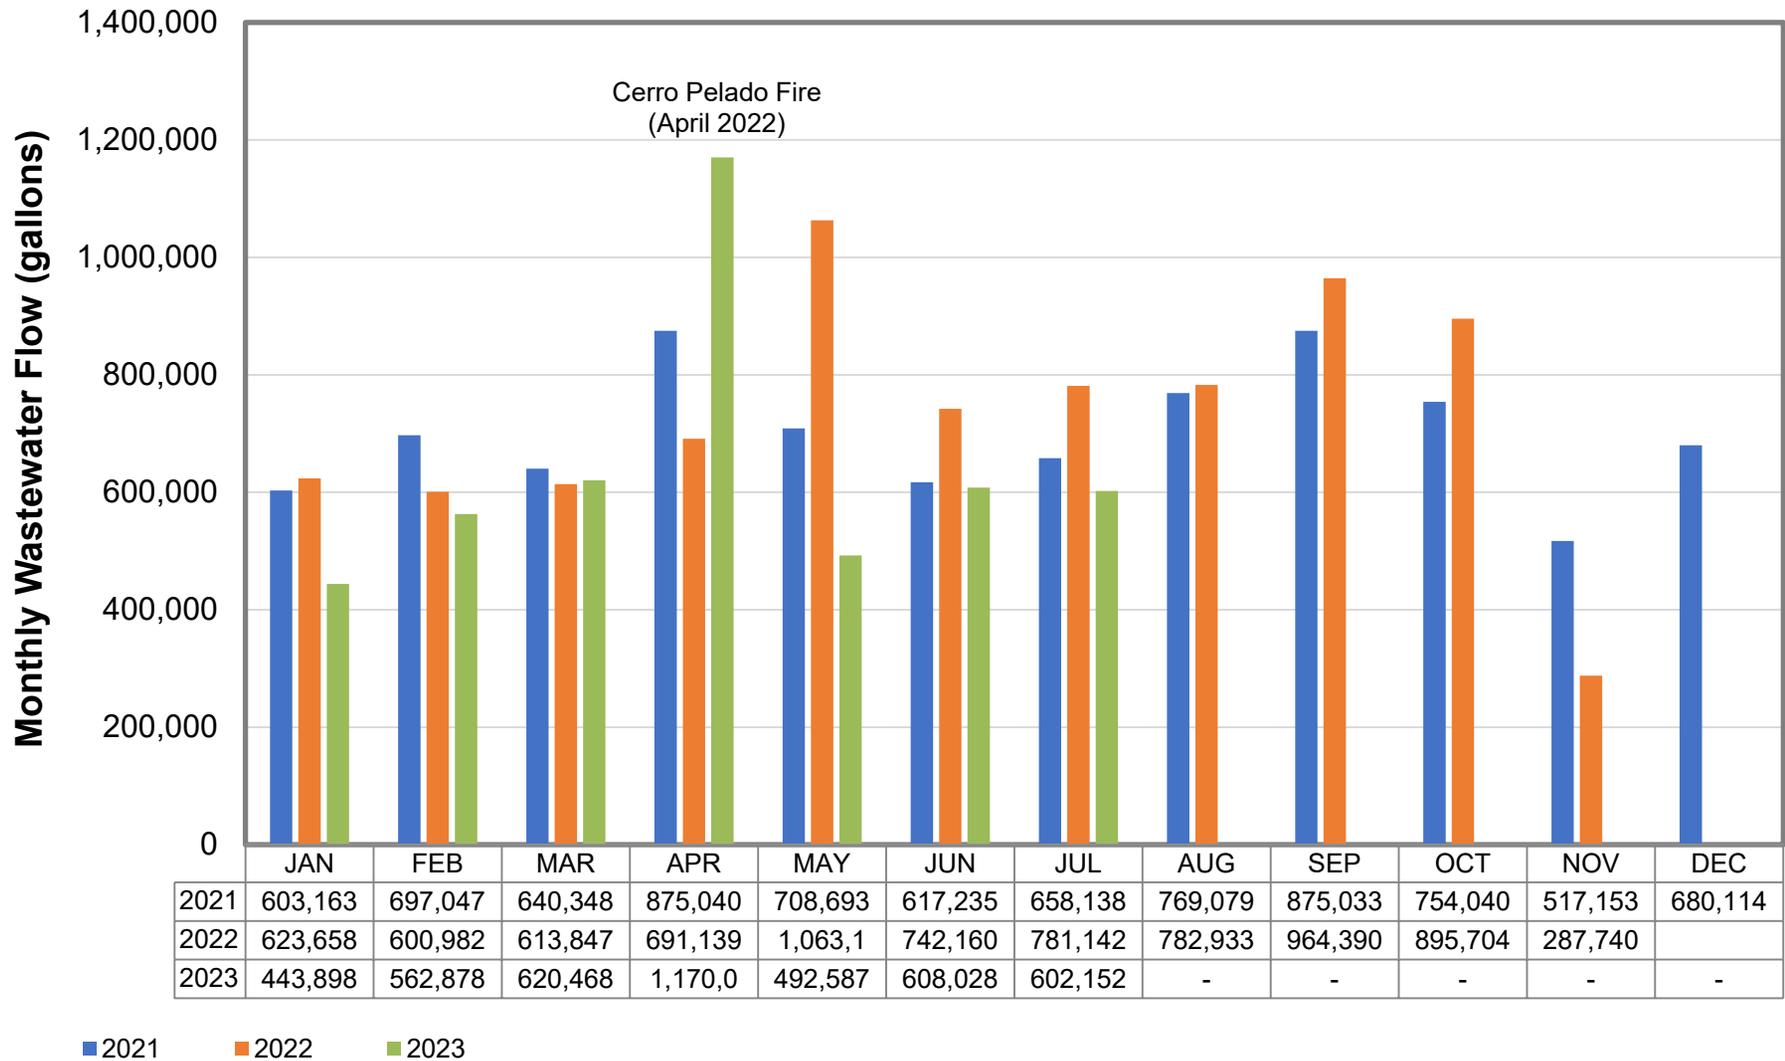
In April 2023, a storm event caused a major sewer main break, and dramatically higher flows were received at the WWTP (Chart 1). In May 2022, water was received at the WWTP from firefighting activities associated with the Cerro Pelado fire.

Based on the data shown in Chart 1, the average daily flow based on monthly totals was 23,719 gpd for 2021, 24,872 gpd for 2022, and 19,737 gpd for the first 7 months of 2023. The average for all three years is 22,775 gpd, which represents 127 gpd per customer connection. For an average household size of 2 persons per connection, the per capita wastewater usage is 64 gallons per capita per day (gpcd). Daily flow, including maximum daily flow, is discussed later in this PER.

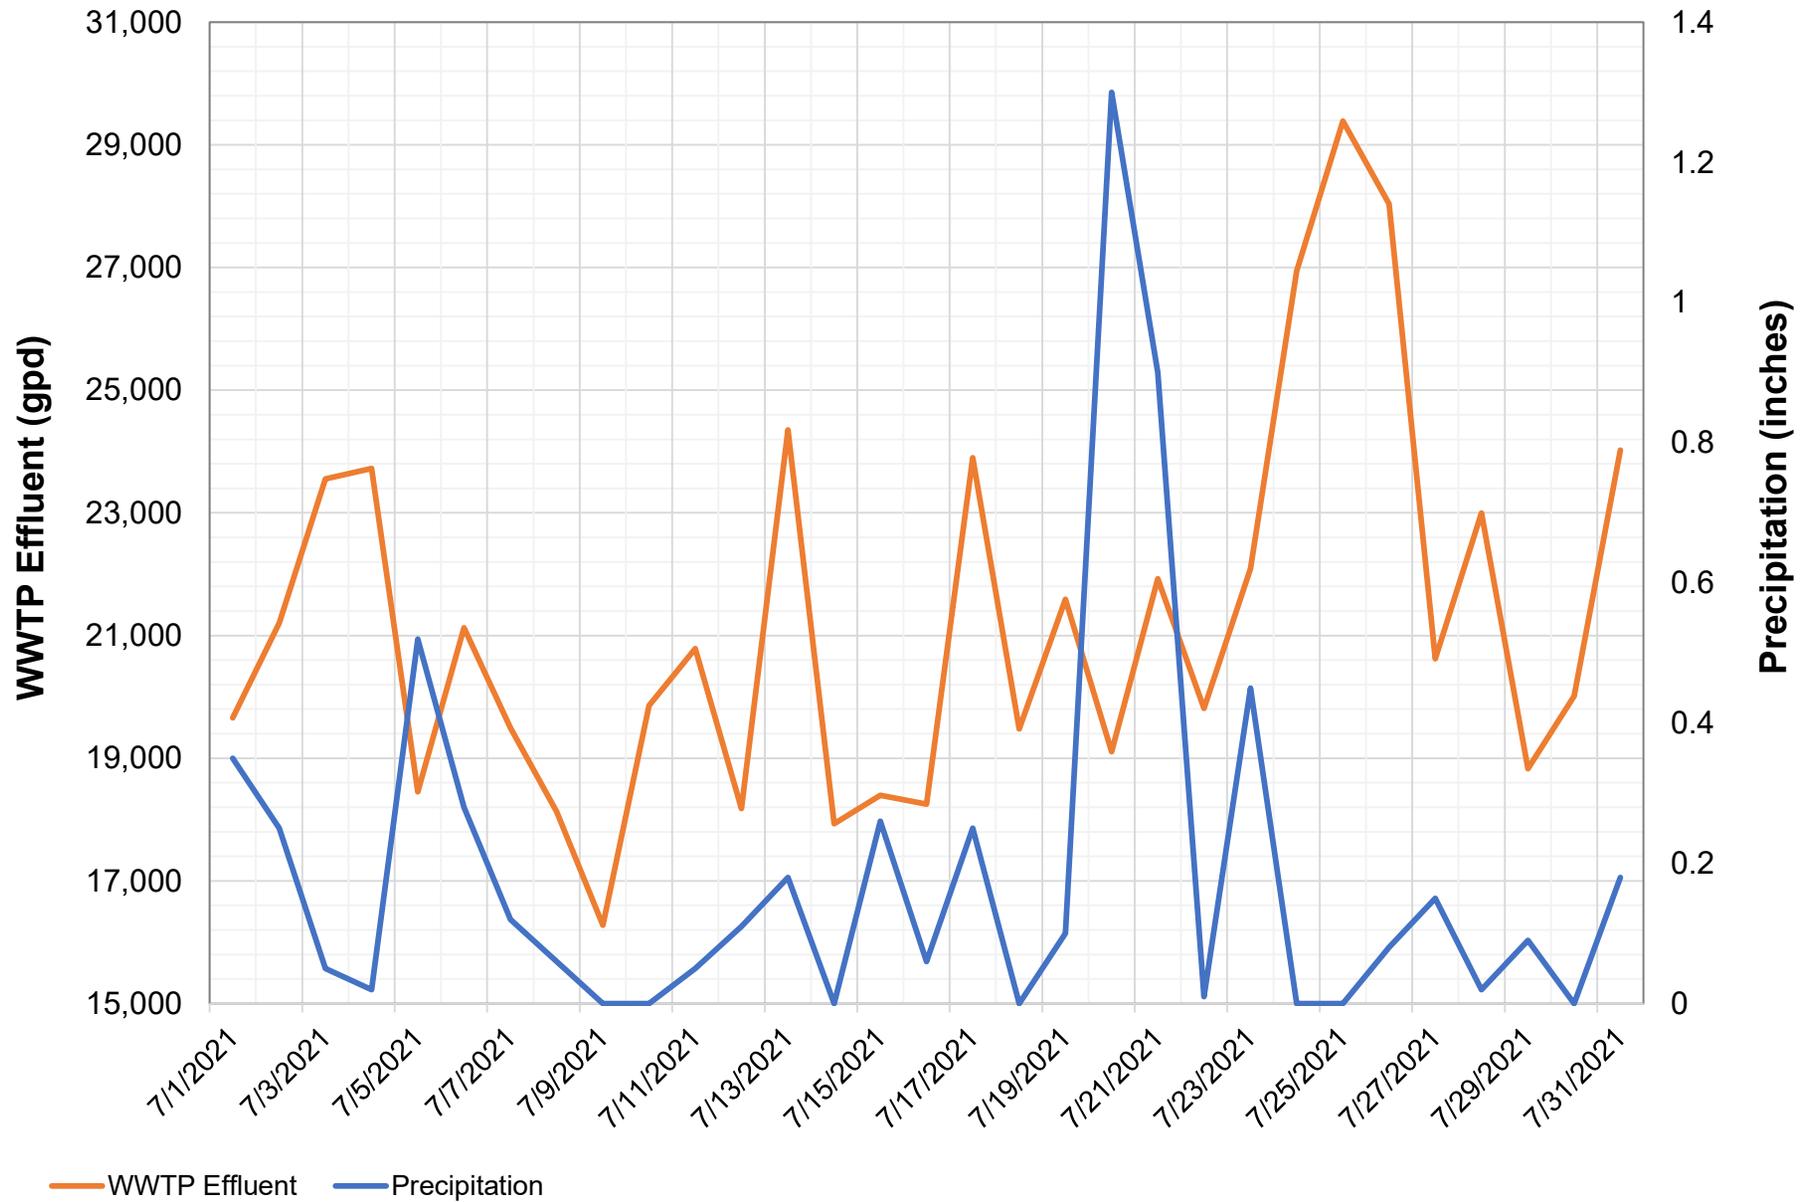
Daily precipitation data and daily effluent data from July 2021 were compared to evaluate potential infiltration in the Village's sanitary sewer collection system. The precipitation data were obtained from the National Weather Service. The closest weather station is the Wolf Canyon station, approximately 15 miles northwest of Jemez Springs. There are similar patterns, specifically between July 21 and 26, 2021. The delay may be due to the location of the weather station and the length of the collection system. The collection system spans over approximately 4 miles, which would take time to infiltrate and travel to the WWTP. The data suggest that precipitation is infiltrating the collection system, and support the variation in flows experienced at the WWTP (NWS, 2023).

During the manhole inspections conducted by DBS&A, it was observed that there was a clear steady flow at all times of the day along the main sewer interceptor on three different days. This

observation suggests that infiltration is occurring in the collection system from the Jemez River, as there had been no precipitation during this time. The flood that occurred in April 2023 caused damage to the WWTP and sanitary sewer collection system. U.S. Geological Survey (USGS) stream gauge data were obtained for the month of April 2023, and were compared to daily WWTP effluent recorded flows. Chart 3 shows this comparison and the correlation between higher stream flows and higher WWTP flows (USGS, 2023).

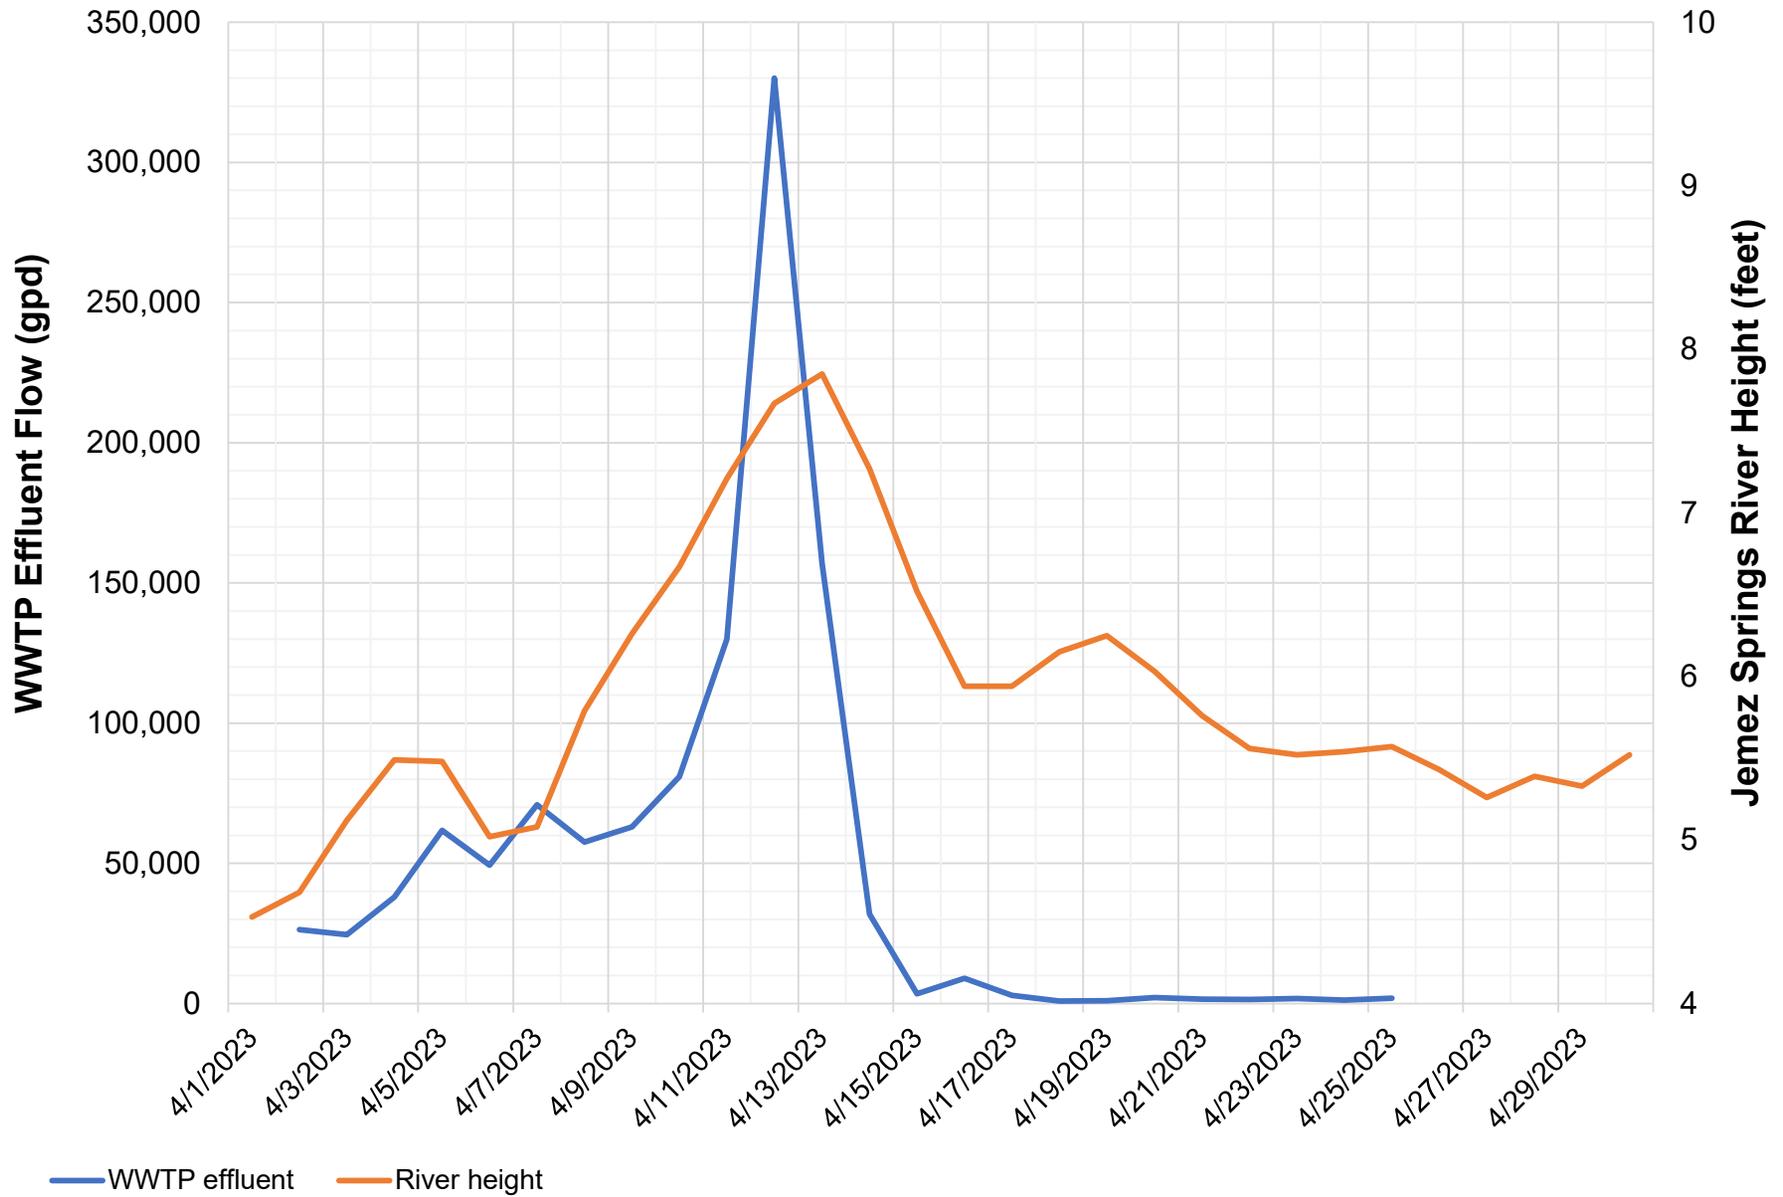
Chart 3

Both the influent and the effluent flows are metered, but the influent meter was not working until April 2023. The Village provided daily effluent meter readings for 2021, 2022, and January through July 2023, and provided daily influent meter readings for April through July 2023. Due to the lack of influent meter readings, the effluent data will be used for the wastewater flows. According to the meter readings for the last three years, the average daily flow (ADF) was

22,775 gpd and the maximum daily flow (MDF) was 60,735 gpd. The wastewater usage is summarized in Table 1.

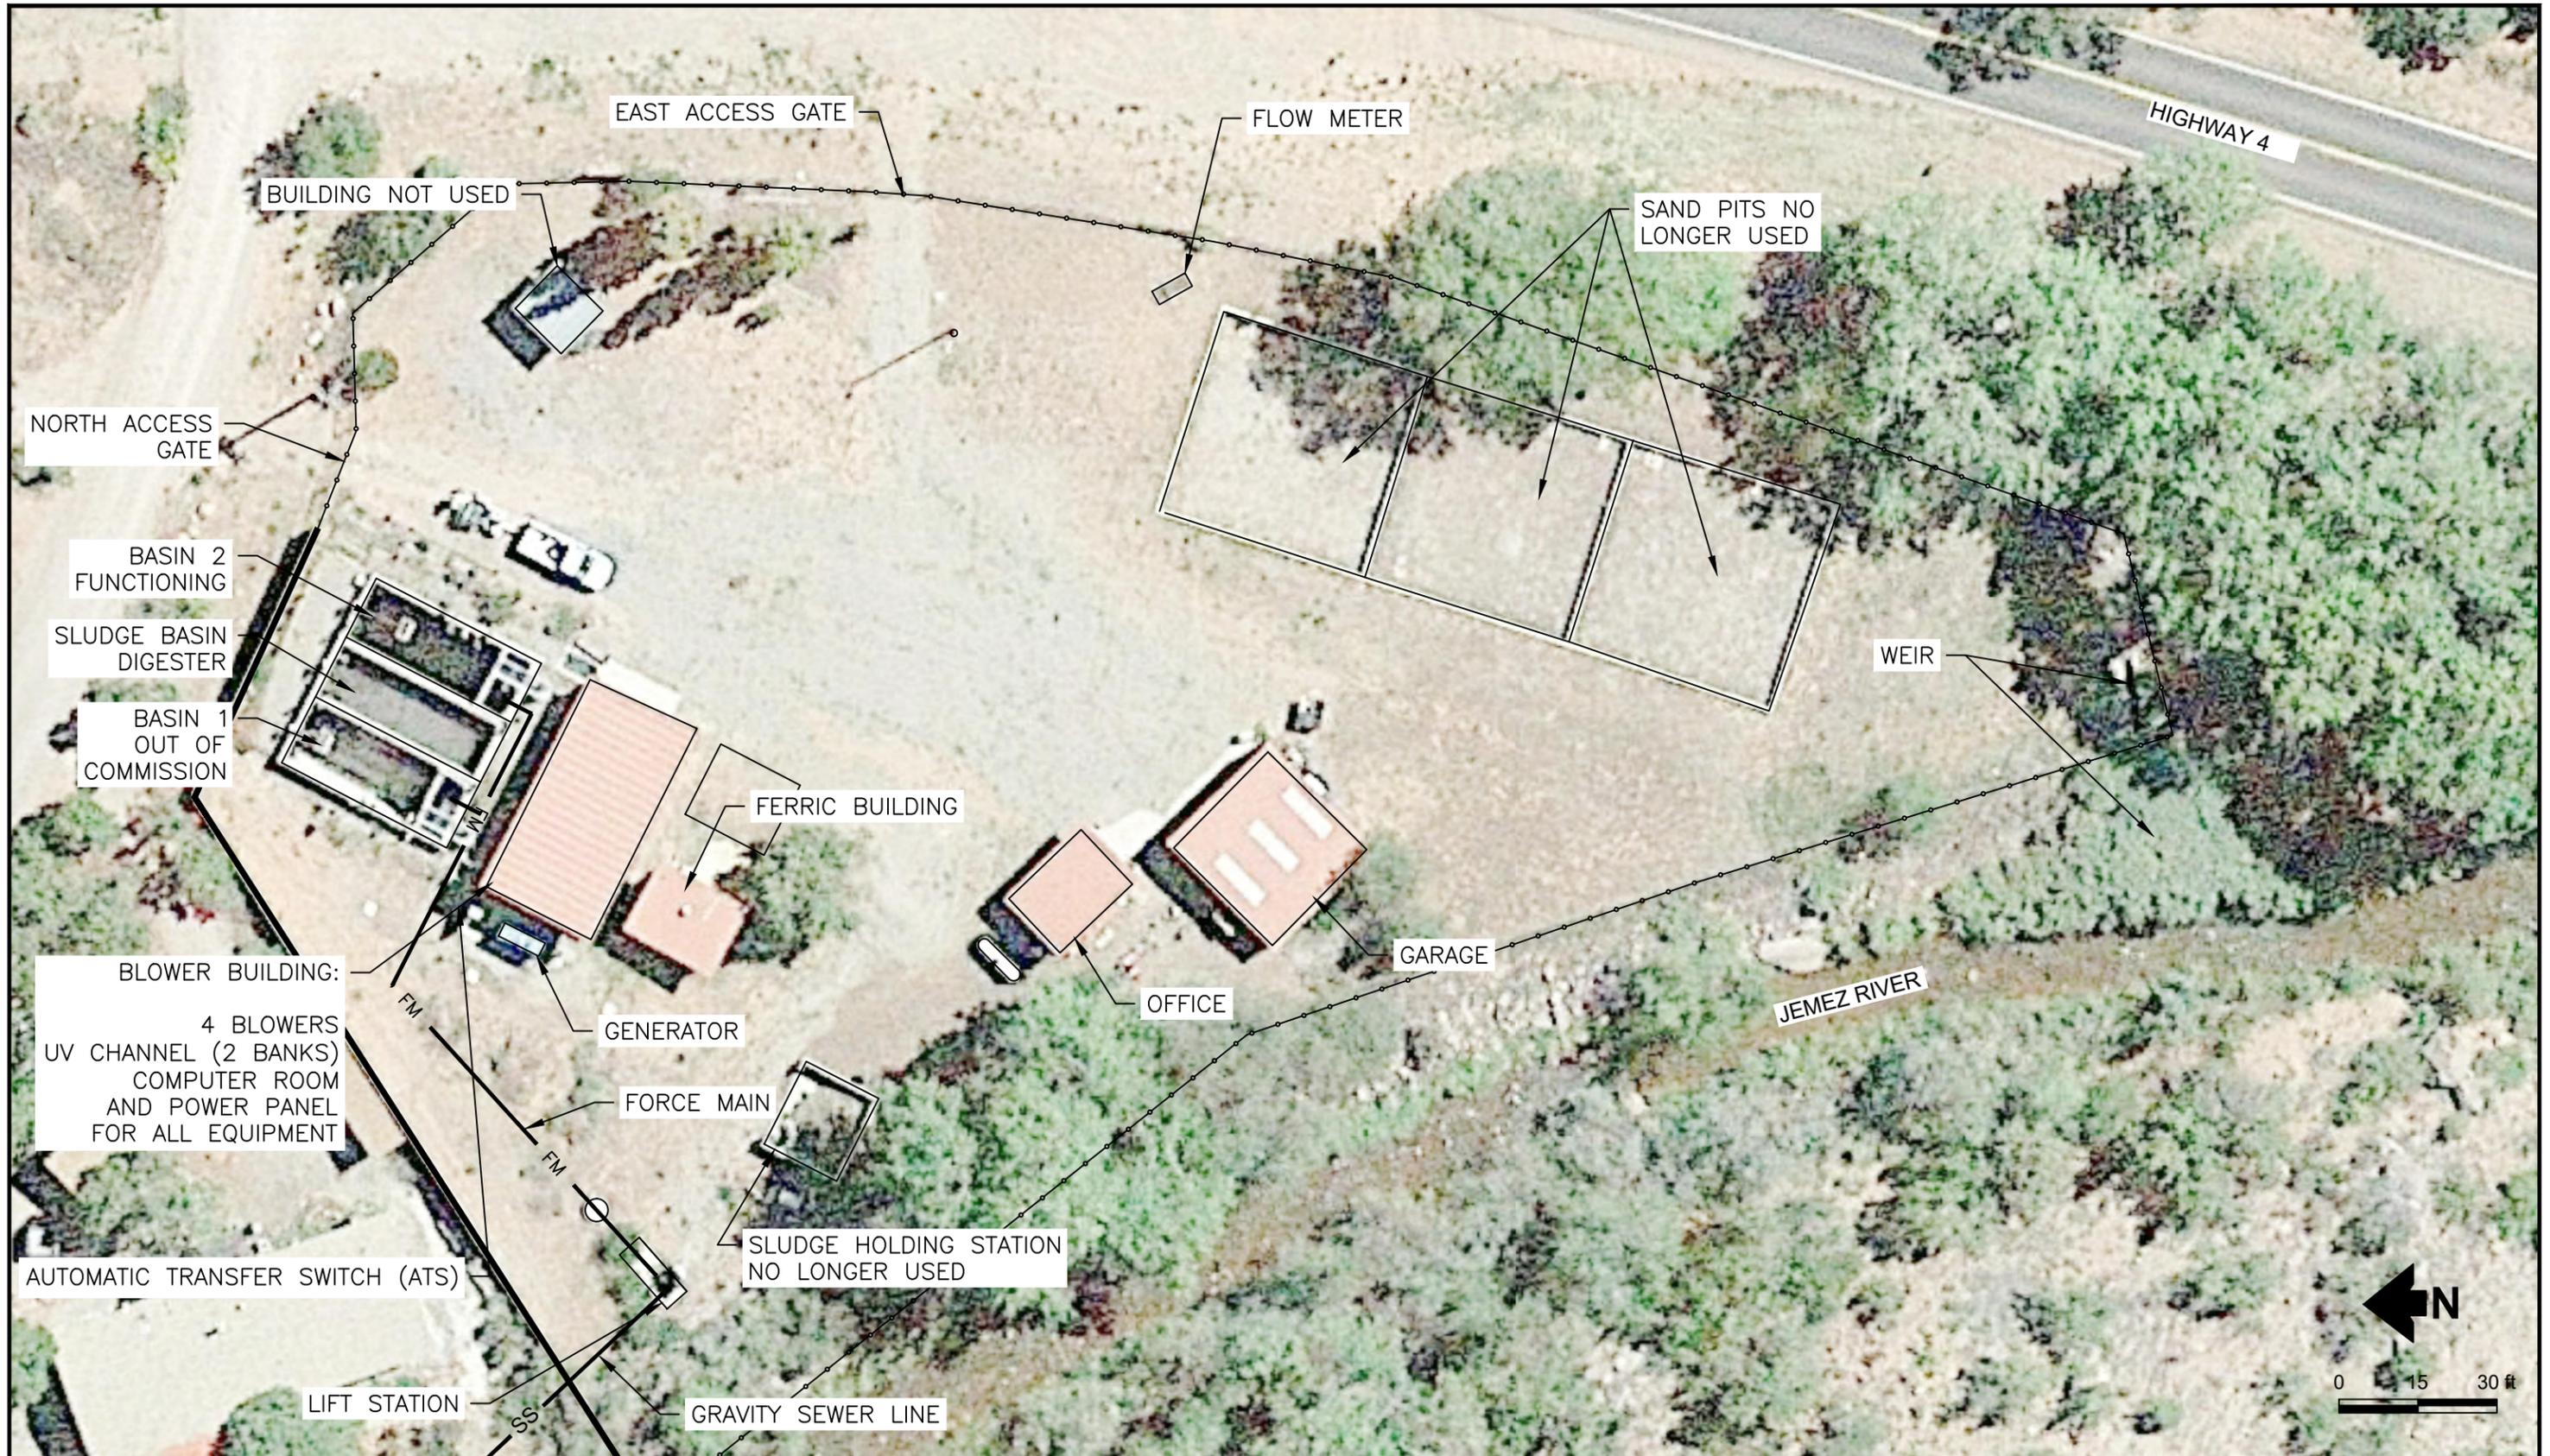
VILLAGE OF JEMEZ SPRINGS  
 WASTEWATER SYSTEM PER  
**Existing Wastewater System**

Figure 2 shows the existing wastewater system, including sanitary sewer manholes, and the location of the WWTP.

The maps of the existing collection system and WWTP are included as Figures 2 and 3, respectively.

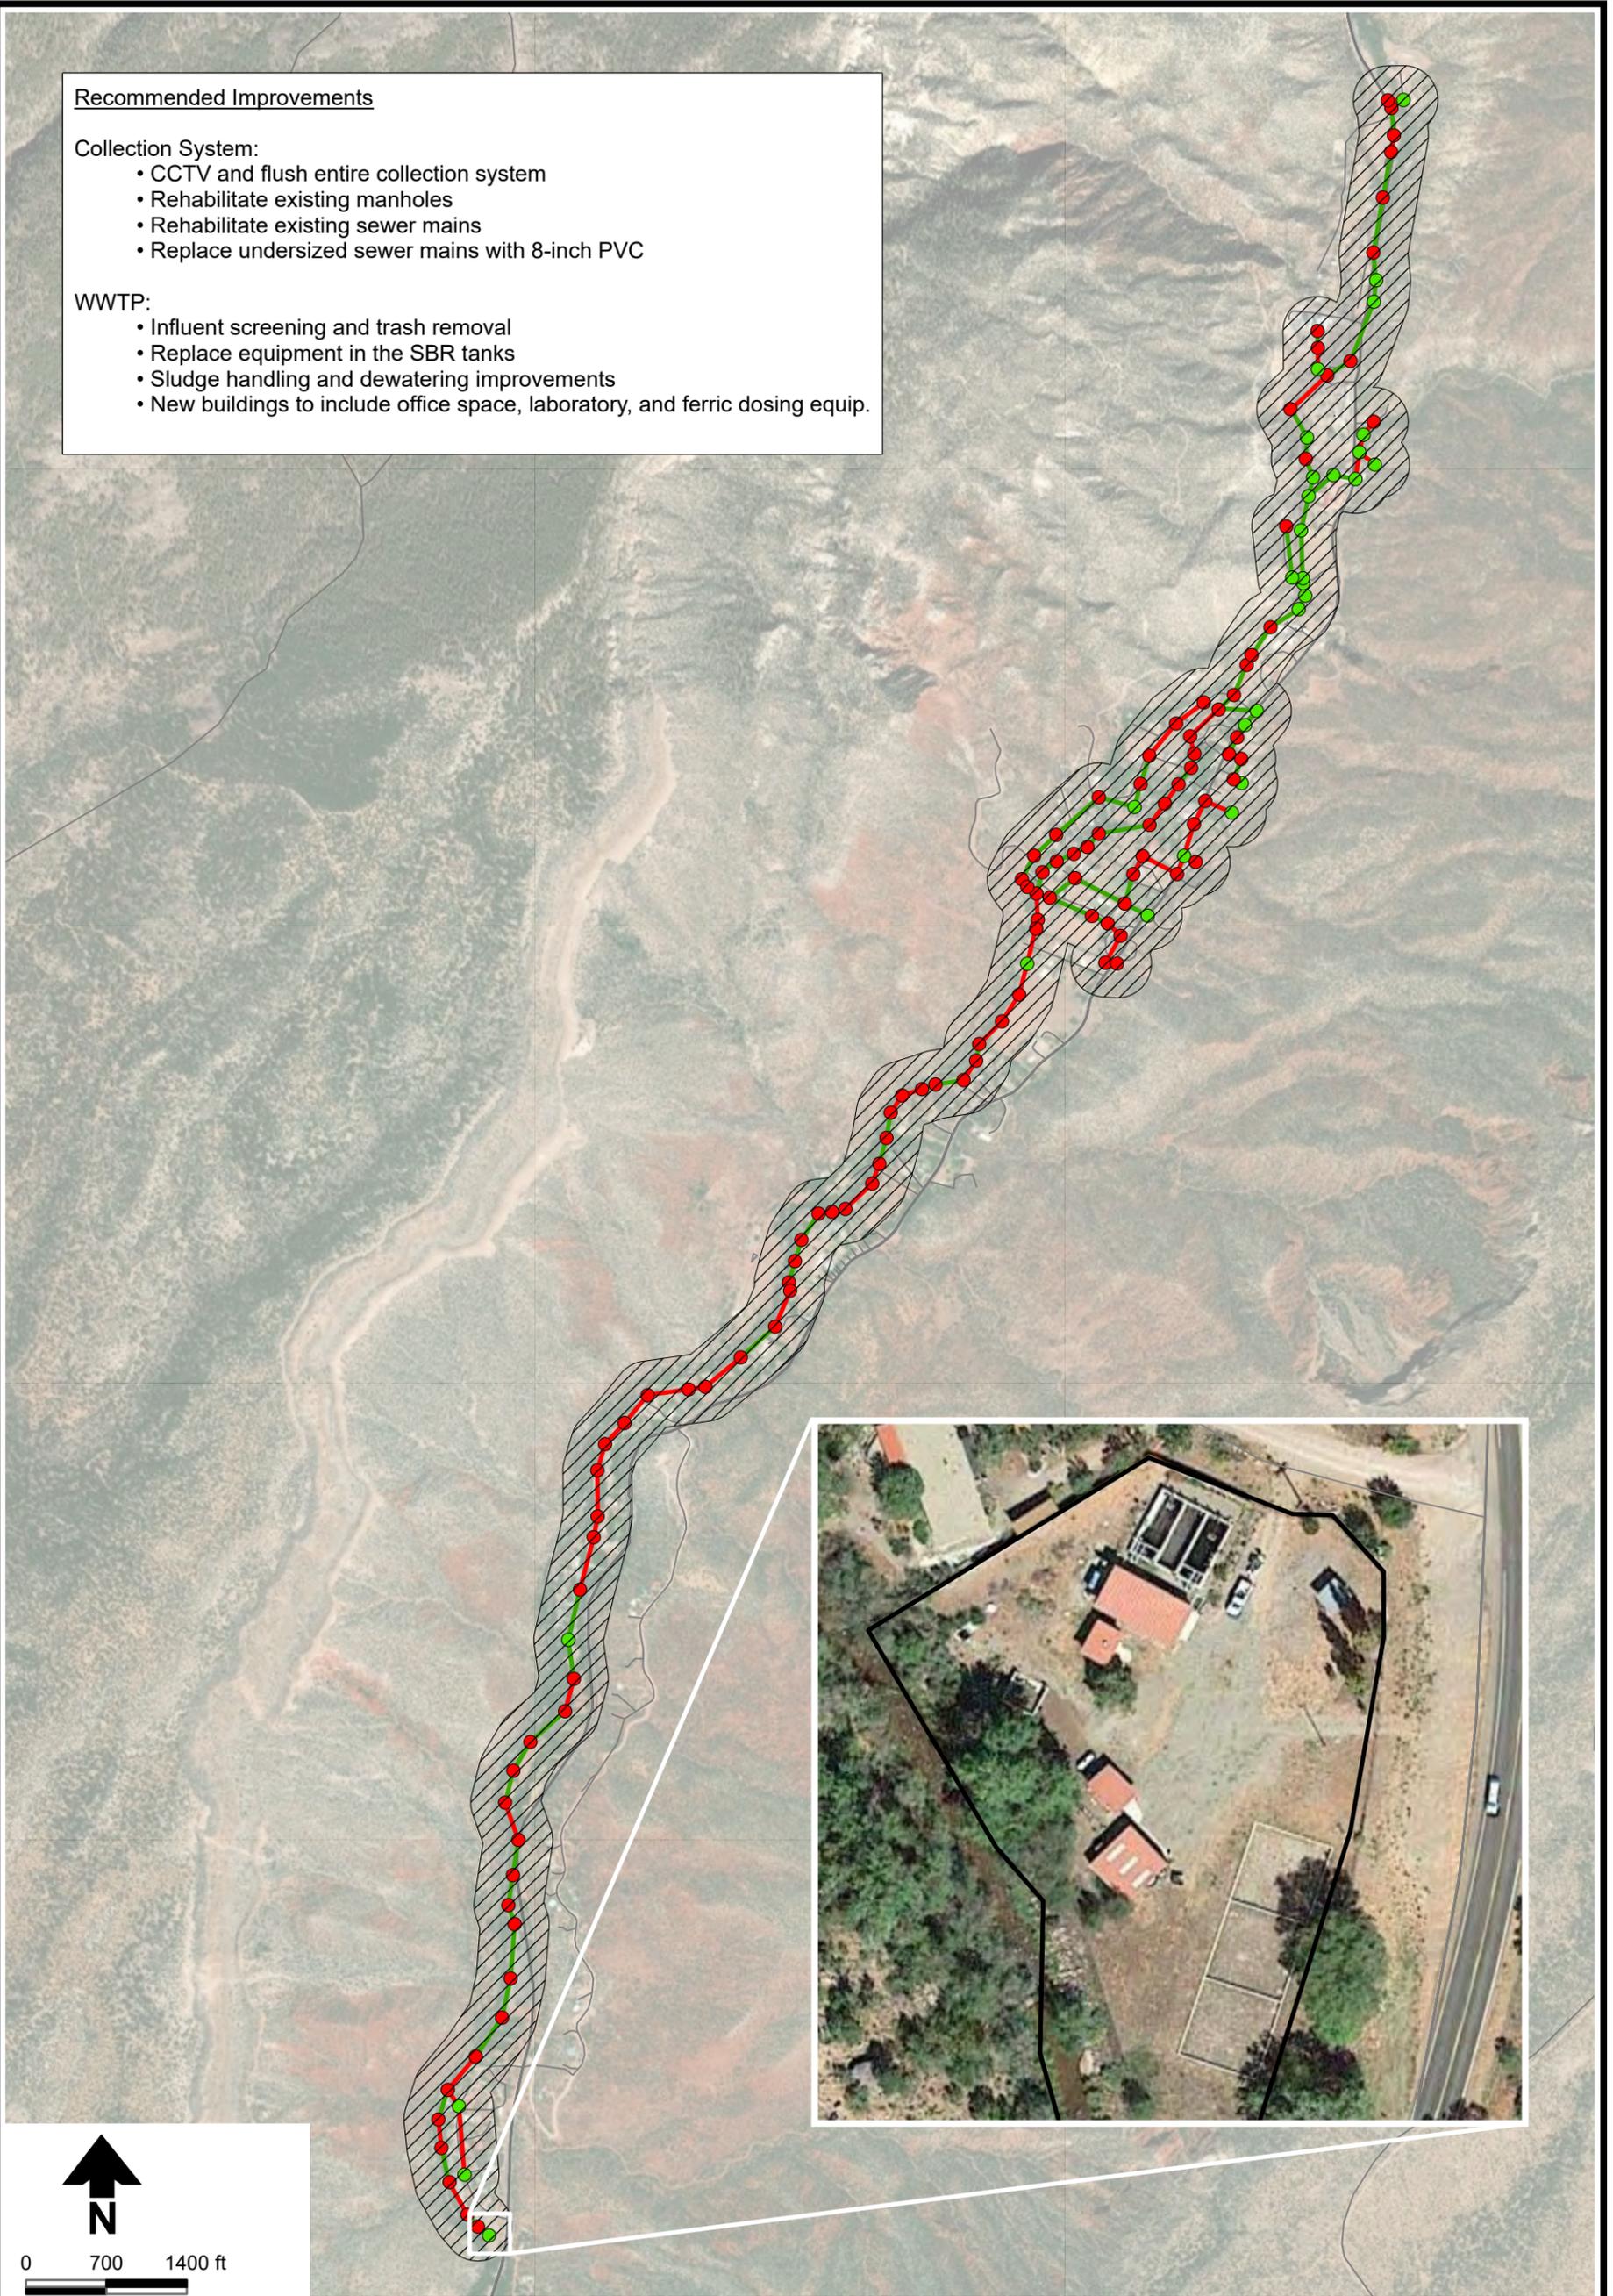
VILLAGE OF JEMEZ SPRINGS WASTEWATER SYSTEM PER  
**WWTP Alternative 3: Replace Existing WWTP**

**Recommended Improvements**

- Influent screening and trash removal
- Replace equipment in the SBR tanks
- Sludge handling and dewatering improvements
- New buildings to include office space, laboratory, and ferric dosing equip.

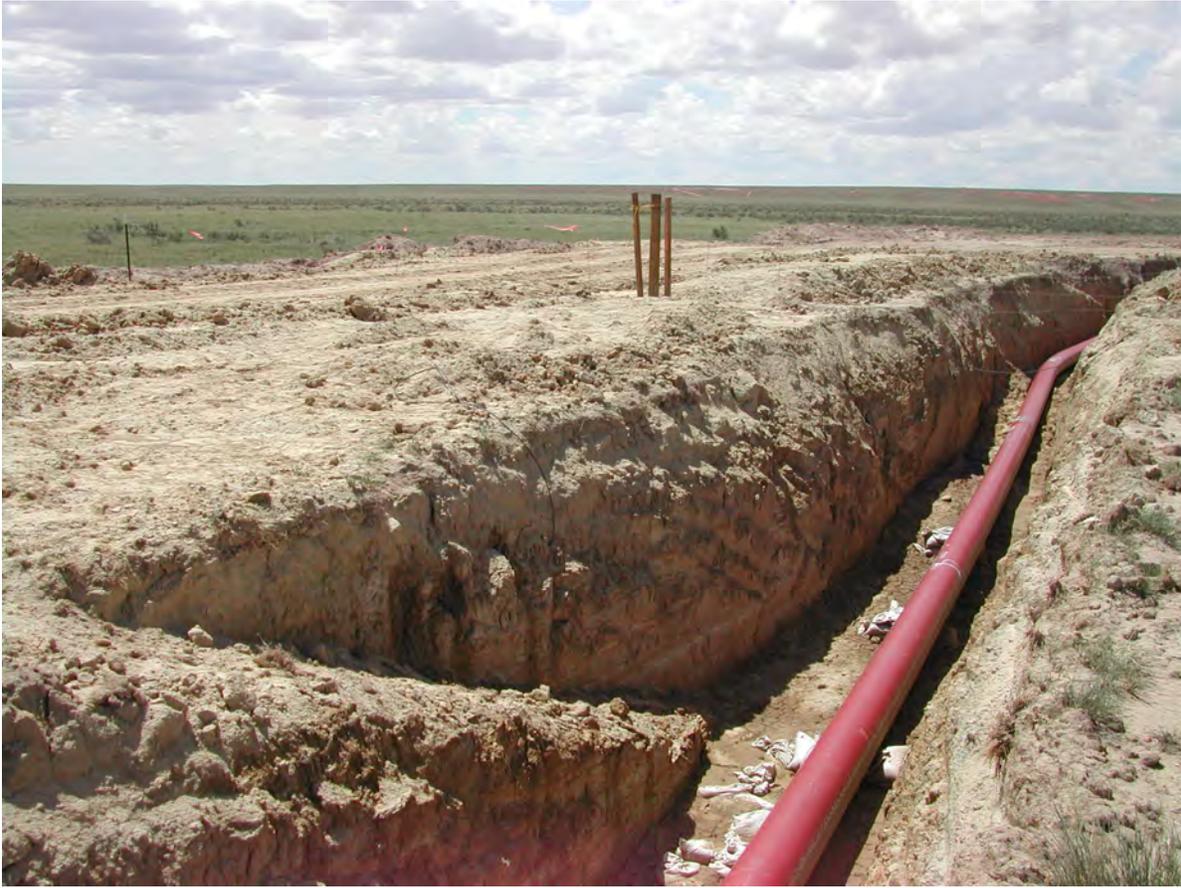
Escape ramps allow trapped wildlife to leave the trench. Photo M. Watson.

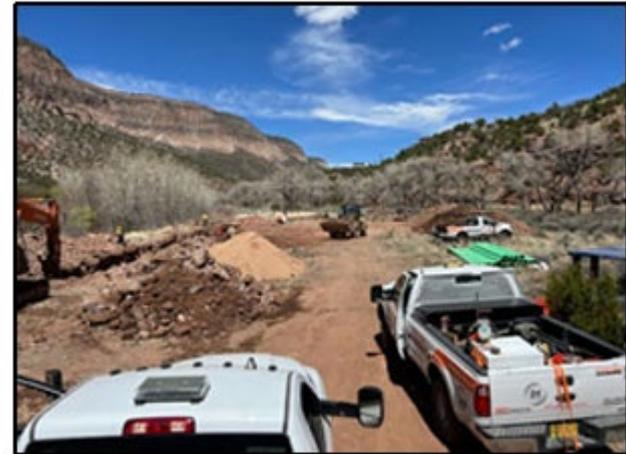
- In April 2023, snowmelt caused the Jemez River to flood
- Sewer main wastewater line broke
- River water, mud, and rocks overflowed the wastewater treatment plant
- Emergency measures were taken by the Village and Sandoval County
- Significant rainfall caused a second incident on November 18, 2023

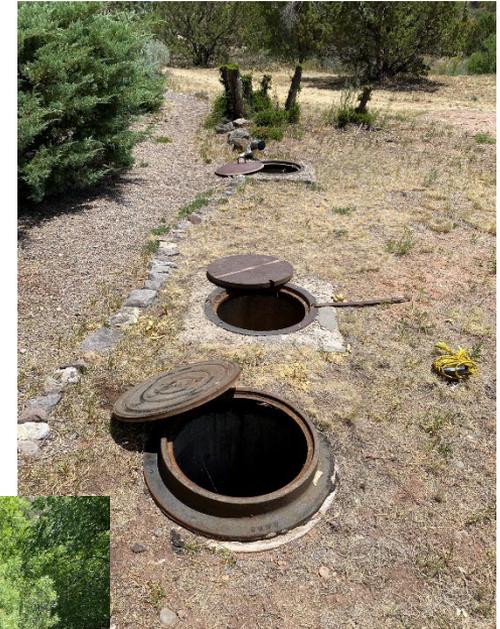
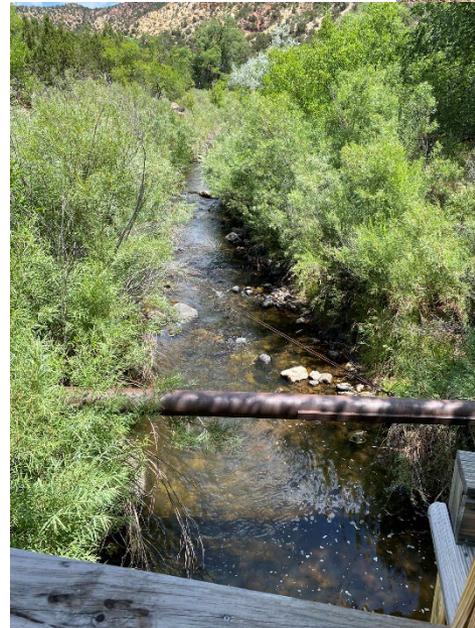
- Closed-circuit television (CCTV) inspection of sewers, completed in 2004 by Wilson & Co., revealed deficiencies in the sewer system
  - Root intrusion,
  - Sags in the sewer lines,
  - Rocks in sewer lines, and
  - Eroded manholes.
- DBS&A inspected 91 of 135 manholes, July 2023
  - Infiltration
  - Root intrusions
  - Erosion/cracks
  - Sediment/blockage

Sanitary sewer manhole inspections were conducted by DBS&A in July and August 2023. Approximately 90 of 135 manholes were located and inspected; those not inspected were due site access issues, or due to covers being paved over or buried. Some of the manholes were found to have root intrusion or were broken in some way and in need of repair. The sewer interceptor appeared to have a steady clear flow throughout all times of three separate days, which indicates that there is infiltration and inflow. Infiltration refers to groundwater that enters the sewer system through holes, cracks, joint failures, and faulty connections. Inflow is water that flows directly into the sewer system from a source that could include storm drain cross-connections or, in the case of Jemez Springs, river water that could enter through manhole covers.

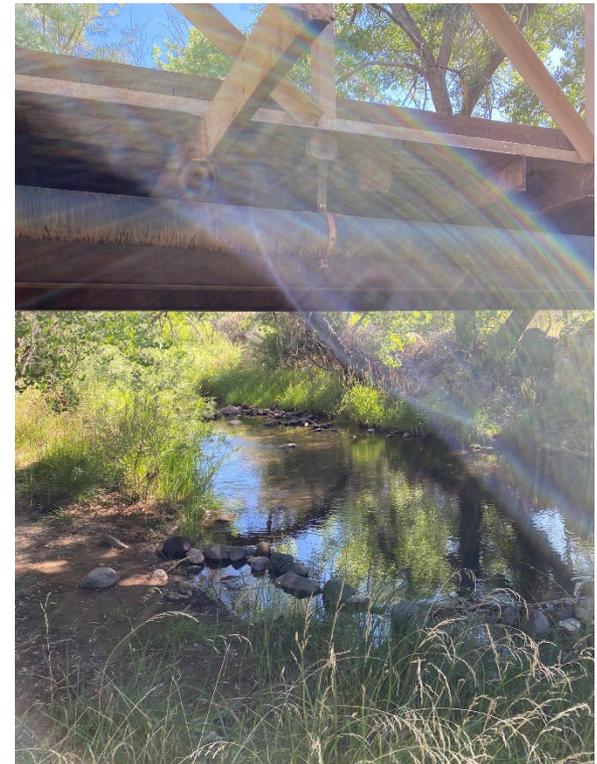
Line attached to bridge crossing Jemez River

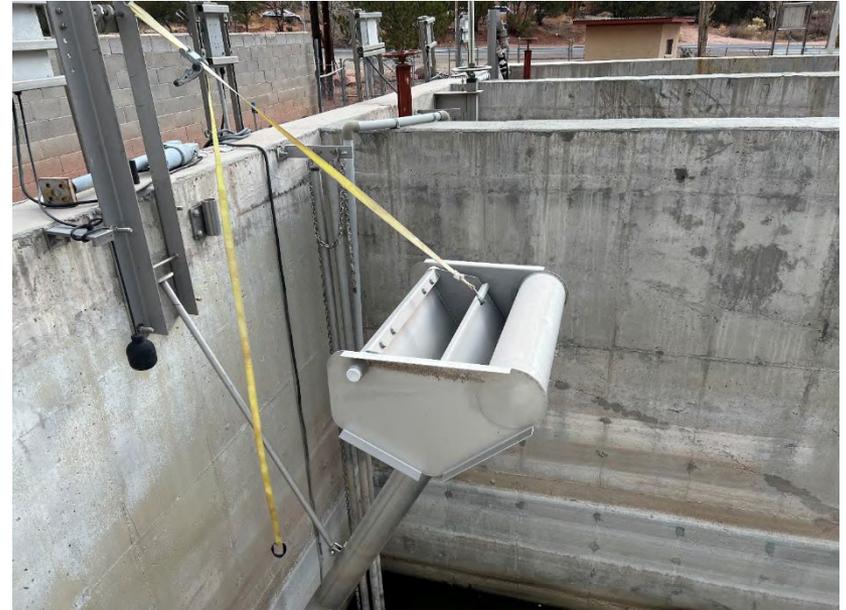
Out of service decant arm at WWTP

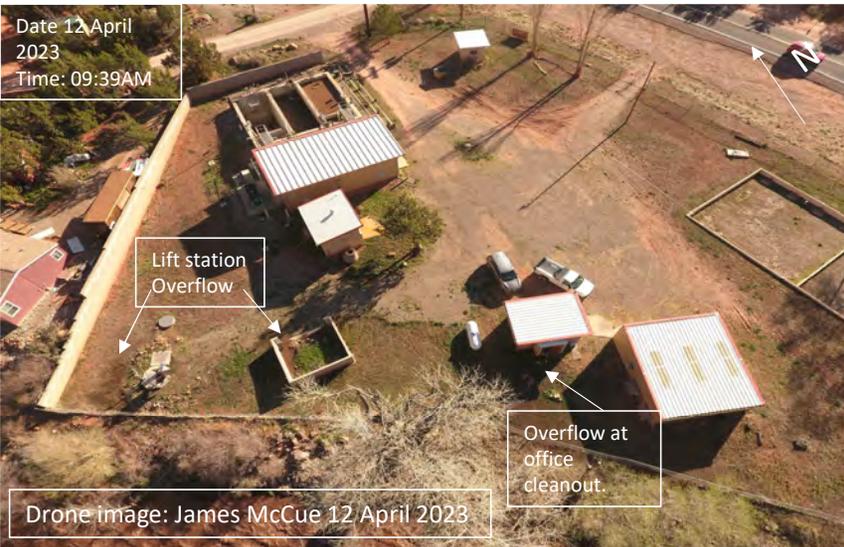
Drone image: James McCue 12 April 2023

- American Pumping initial company contacted due to after hours support and began rotational hauling of waste from JSWWTP
- Both pumps at lift station failed. Reset pumps, pump #2 failed within 30 seconds and later (time unknown) pump #1 failed; pump #1 unable to reset due to ground saturation and water pooling directly in front of electrical panel. Later that night, approximately 11:30PM, pump #1 was reset and it has continued to function. Pump #2 would not reset.

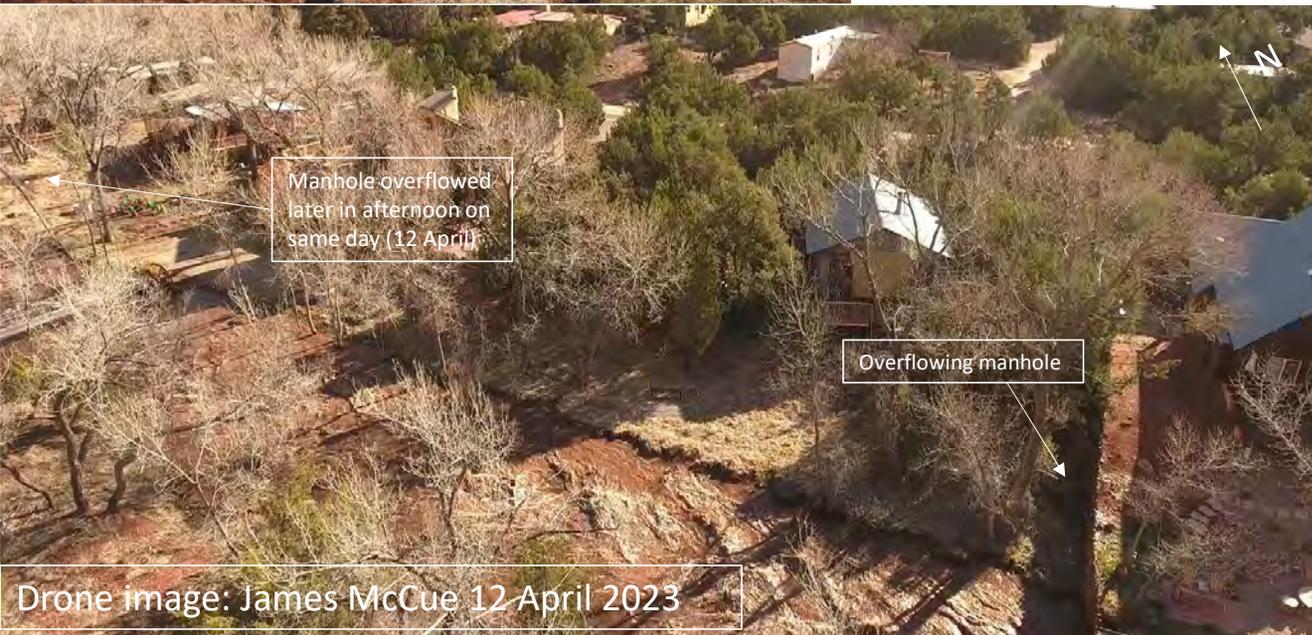
Drone image: James McCue 12 April 2023

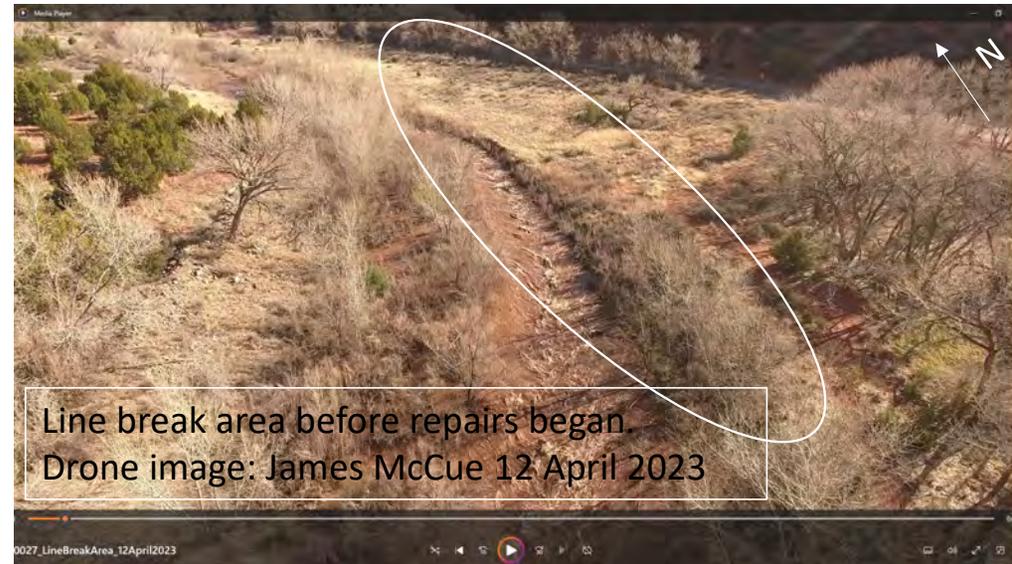
- **14 April**
- Mountain Pacific located line break.
- Upon MP reporting, Mark Hatzenbuhler from Sandoval County coordinated with B&D (contract company with SC) to run camera at line break location.
  - At 150' obstruction observed within line.
  - B&D plugged the manholes to the north and south of the line. Prepared to trench for new line on 15 April.
- Aeration blower #1 failed. Later discovered diffusers in basin covered with sand/sludge
- **15 April**
- Manholes plugged north/south of line break. Waste pumping from manhole north of break began while pumping continued from JSWWTP.
- B&D began excavation of trench for relocation of replaced line.

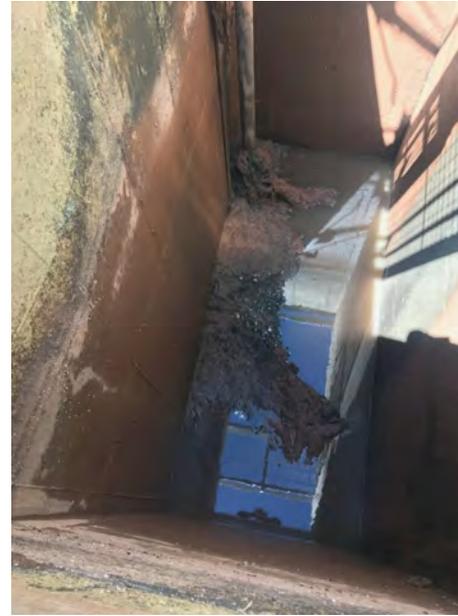
Grit chamber Basin #2  
Image taken by Mark Hatzenbuhler (Sandoval County) 18 APRIL 2023

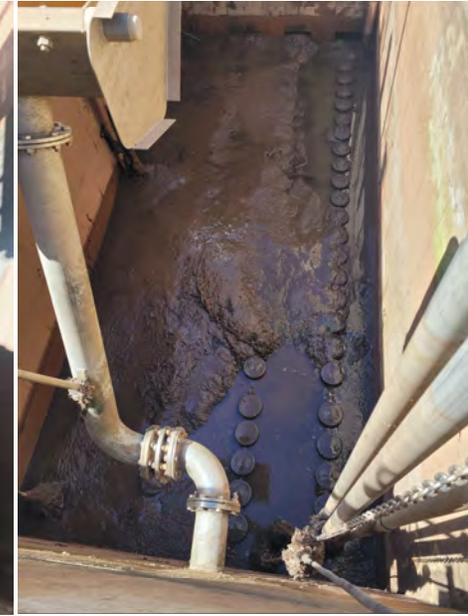
Aeration section of Basin #2  
Image taken by Steve Soto (Mountain Pacific) 18 APRIL 2023

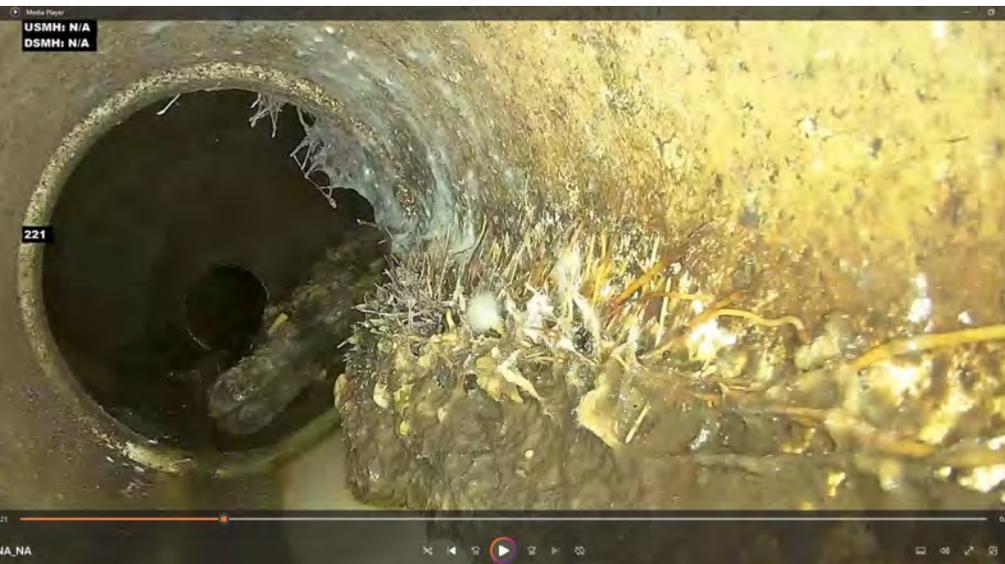
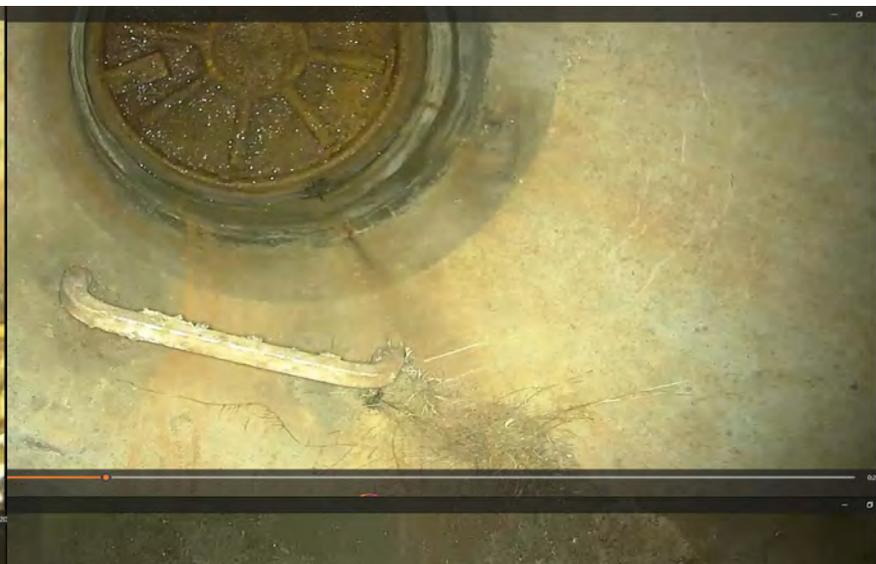
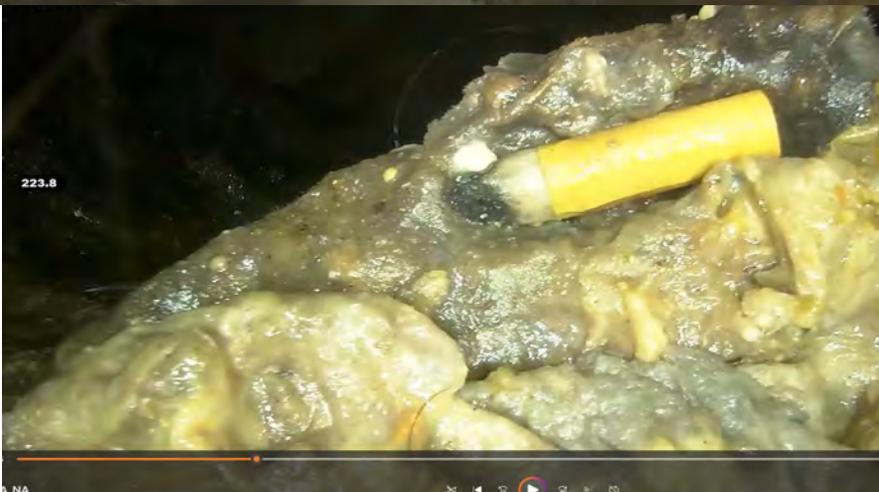
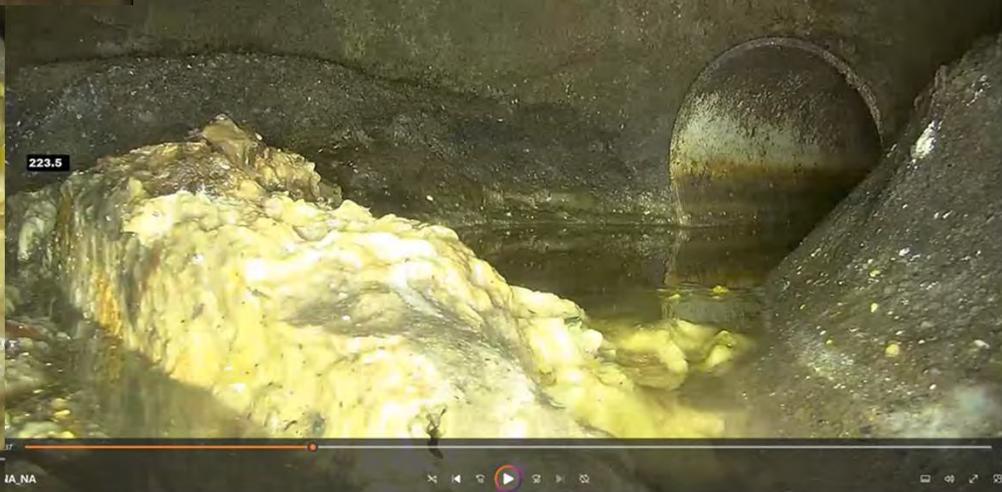
25 April imagery by Albuquerque Water Authority. Root growth, waste, random debris, and river debris visible. Manhole # Unknown. Unable to open manhole; rusted shut.
