# Preliminary Engineering Report

## Wastewater System Improvements

### Village of Jemez Springs, New Mexico

February 2, 2024

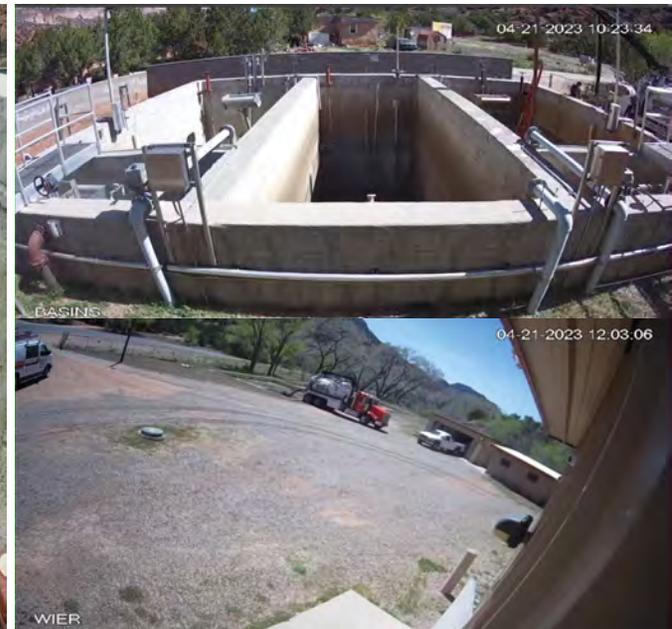
Above camera images from JSWWTP security cameras

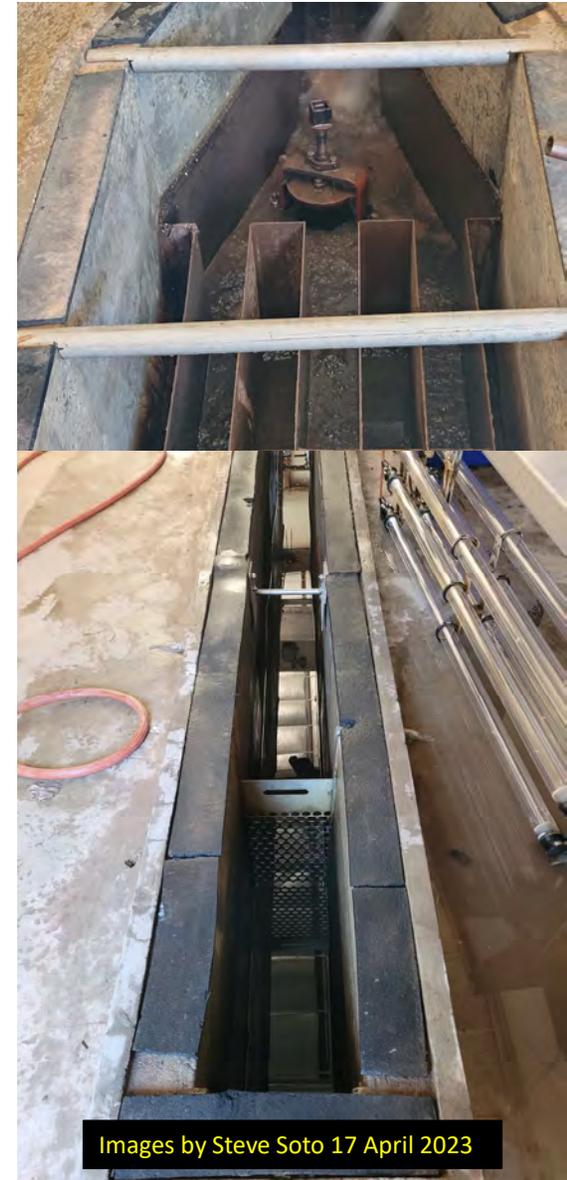
Images by Steve Soto 17 April 2023

- UV Channel drained, modules removed, inspected, cleaned.
- UV Channel walls scrubbed with hard bristle brush and power washed.
- UV modules hosed down.
- UV Quartz covers cleaned.
- Ran high pressure water through pipe from UV Channel to basins to clean line.
- Refilled UV channel with water and replaced UV modules.
  - Appear to be functioning normal.
- No damage from current emergency observed.
  - Normal wear and tear. May need to replace UV lights and possibly entire UV modules (Bank A/Bank B) at some point.

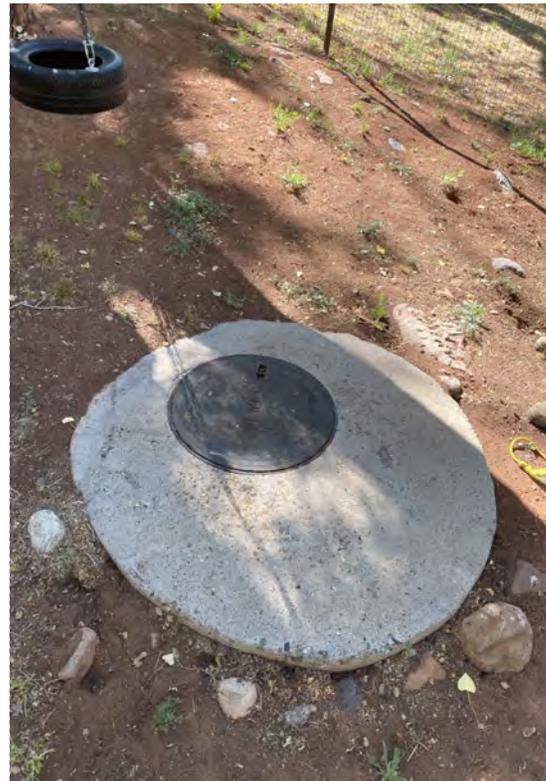
Manhole ID	11
Inspection Date & Time	08/03/2023 3:49pm
Rim Elevation	
Invert Depth	
Invert Elevation	99.00

Completely clogged ( very small flow going out) filled with roots and foot of dirt. Inlet buried outlet buried and 95% clogged

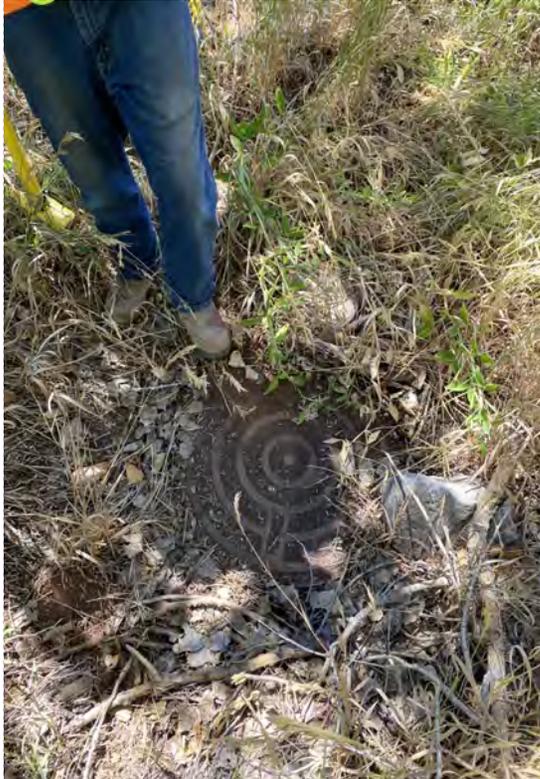
Heavy buildup on shelf. Corrosion - signs of H2S

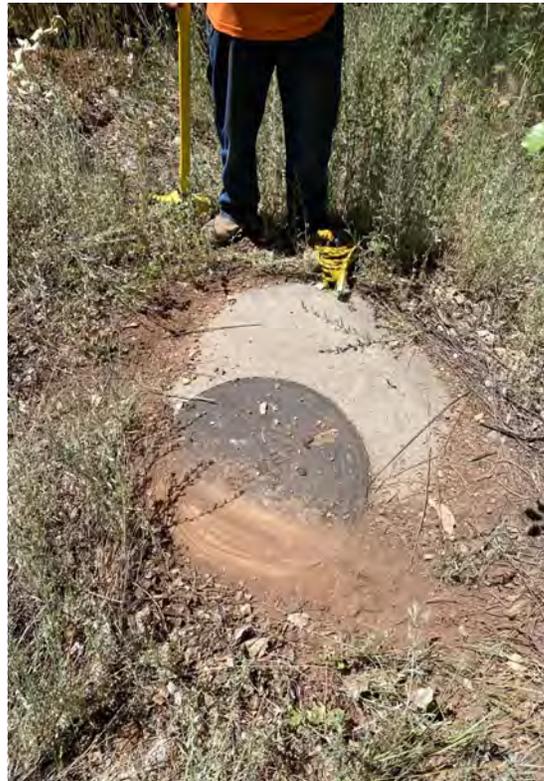
Inflow Indications	Debris on sides/shelf
Surcharge Indications	Grease on shelf
Clarity of Flow	Turbid appearance
Flow	Sluggish
Flow Depth Compared to Adjacent Manholes	Higher
FlowDepth_in	2.00

Large root intrusions, heavy buildup of roots and dirt
--

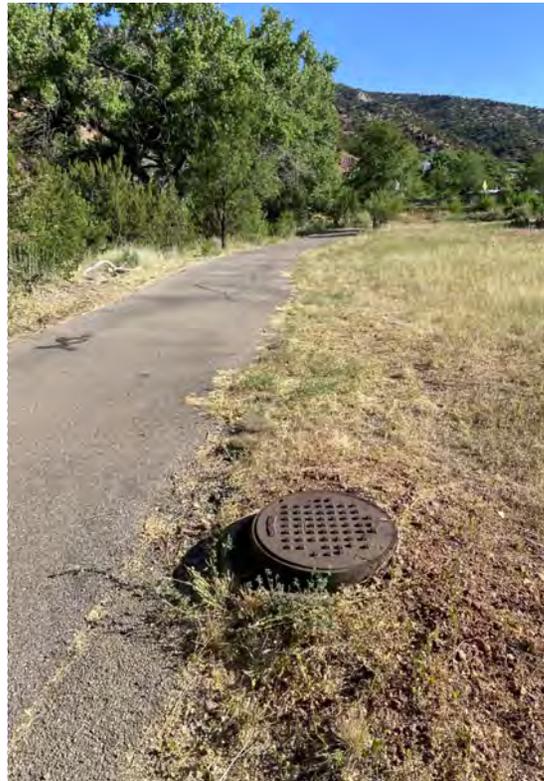
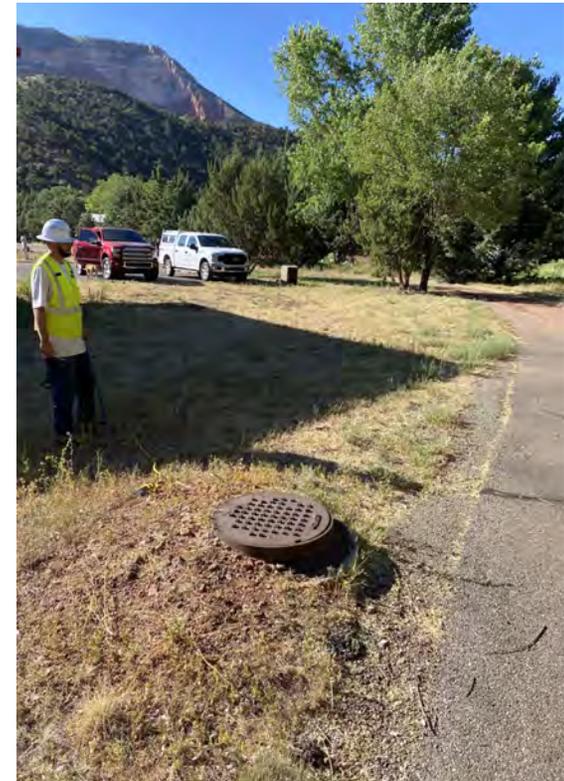
Manhole ID	38
Inspection Date & Time	07/17/2023 2:44pm
Rim Elevation	
Invert Depth	
Invert Elevation	98.00

Vermin	
Steps	Corroded
Cone	Serviceable
Riser	Serviceable
Shelf	Dirty
Channel	Obstructed

Outlet pipe 50% clogged
-------------------------

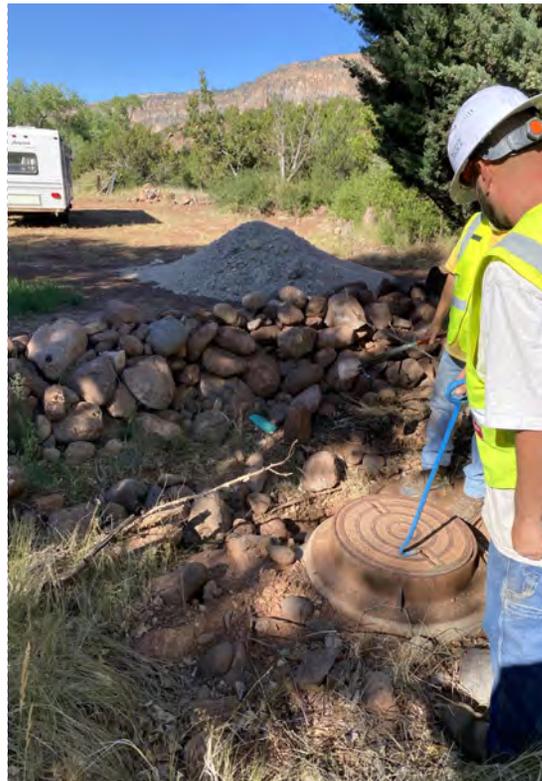
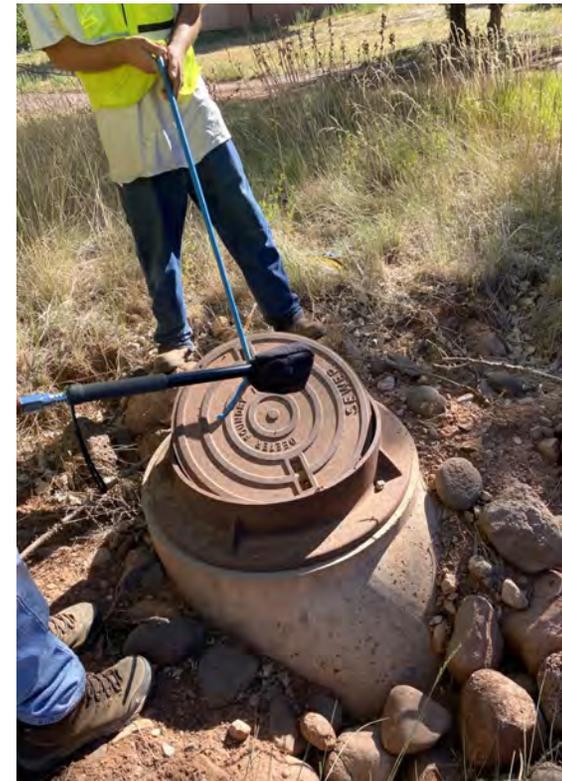
Manhole ID	38B
Inspection Date & Time	07/17/2023 2:55pm
Rim Elevation	
Invert Depth	
Invert Elevation	85.00

Location	Other
Manhole Cover	Serviceable
Ring & Frame	Corroded
Manhole Material	Concrete
Manhole Size	4 foot

Vermin	
Steps	Corroded
Cone	Serviceable
Riser	Serviceable
Shelf	Corroded
Channel	Obstructed

I&I: Pipes buried - channel blocked with dirt, roots. No flow.

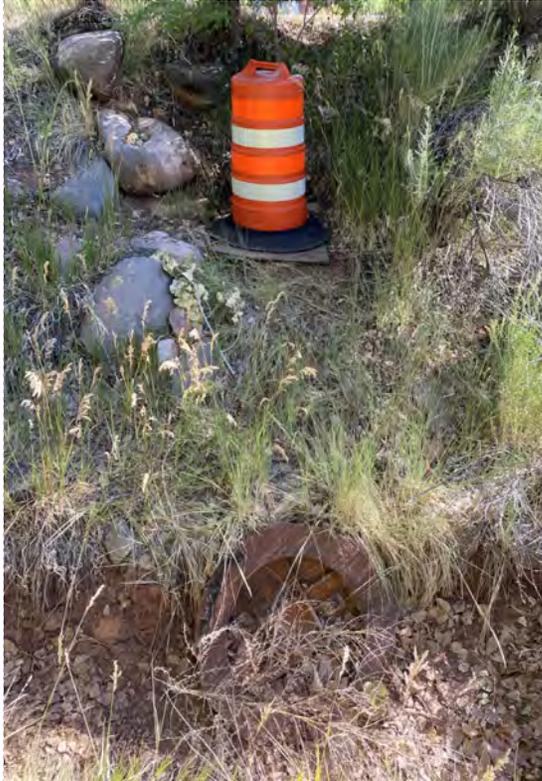
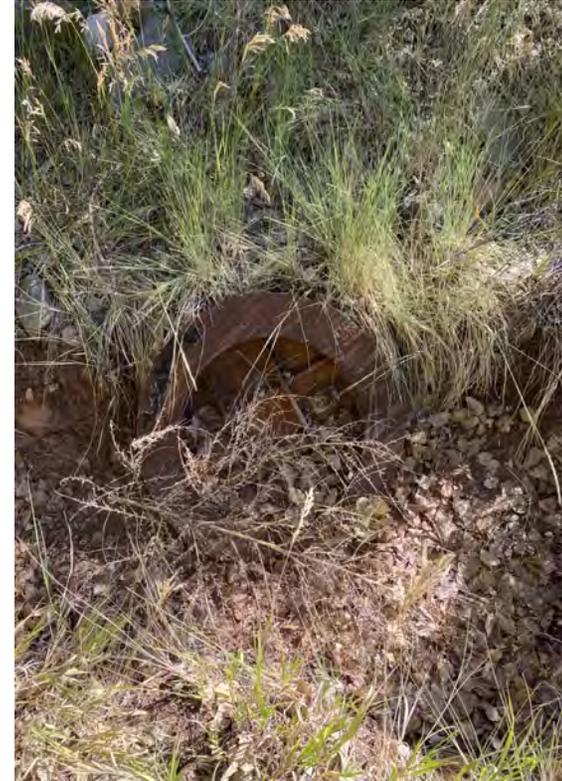
Manhole ID	39
Inspection Date & Time	07/17/2023 2:57pm
Rim Elevation	
Invert Depth	
Invert Elevation	93.00

Missing cover, ring, and frame. Road cone and board on top. Broken collar. 3 drop inlets

Location	Roadway
Manhole Cover	Corroded
Ring & Frame	Corroded
Manhole Material	Concrete
Manhole Size	4 foot

Vermin	Other
Steps	Corroded
Cone	Corroded
Riser	Corroded
Shelf	Broken
Channel	Obstructed

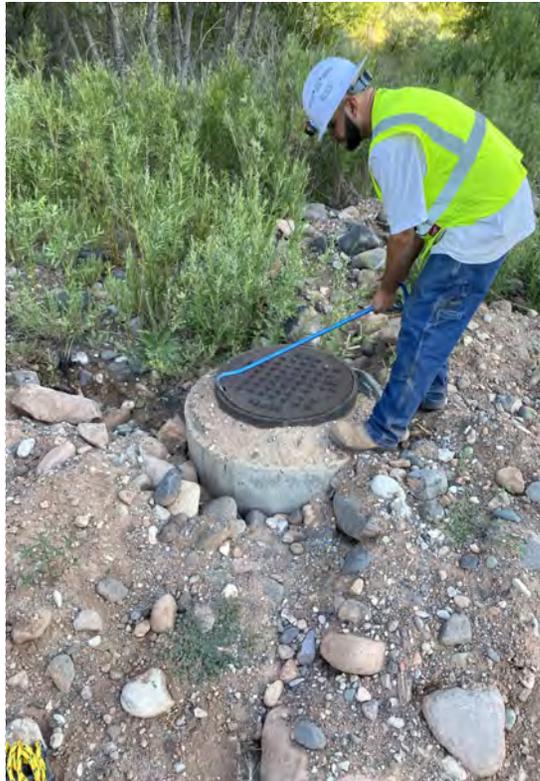
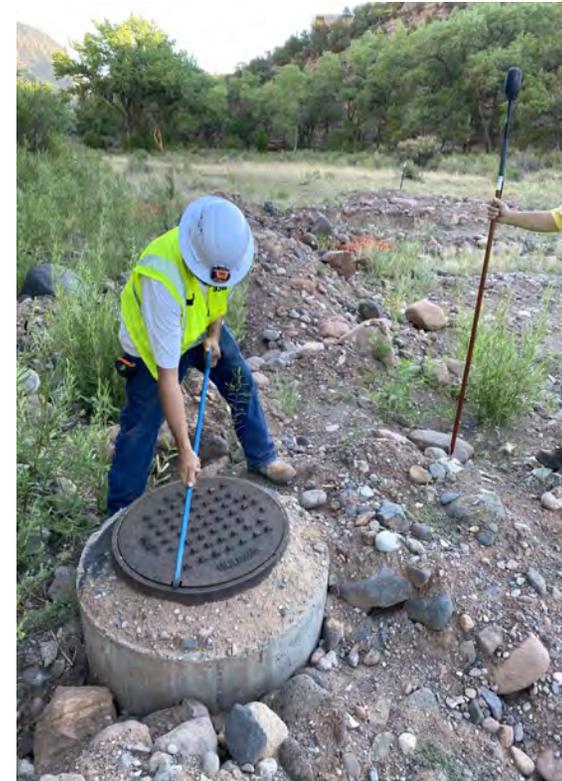
Needs bollards

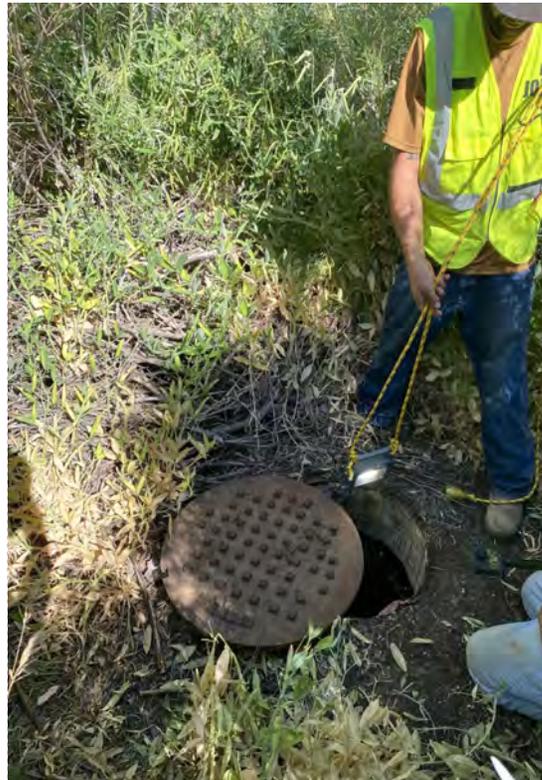
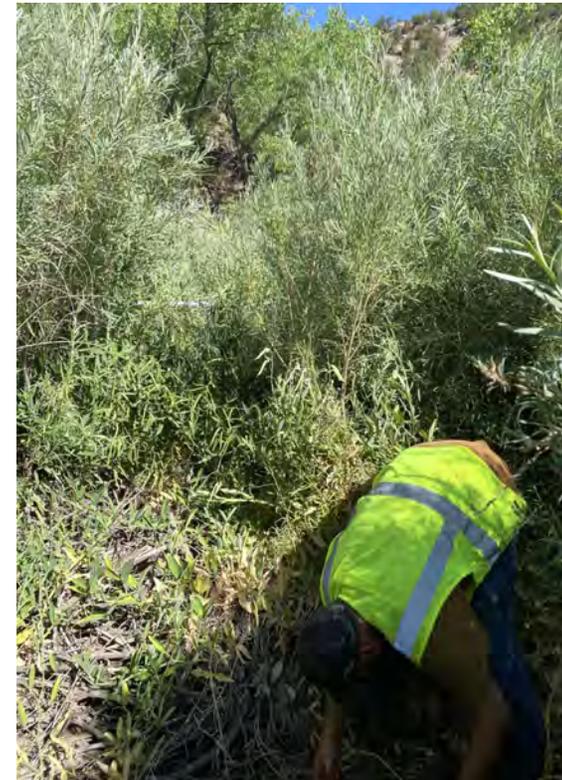
Manhole ID	40
Inspection Date & Time	07/19/2023 3:40pm
Rim Elevation	
Invert Depth	
Invert Elevation	55.00

Vermin	
Steps	Corroded
Cone	Serviceable
Riser	Corroded
Shelf	Dirty
Channel	Obstructed

Dirt buildup on shelf, debris in channel, I&I
---

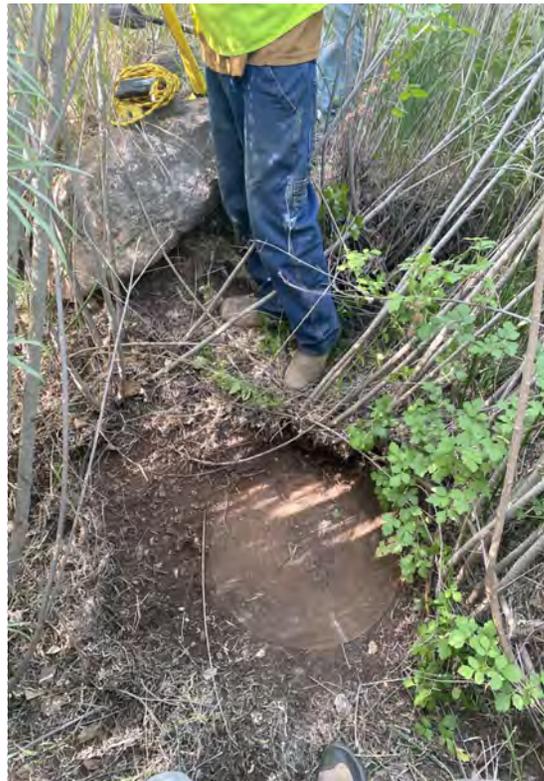
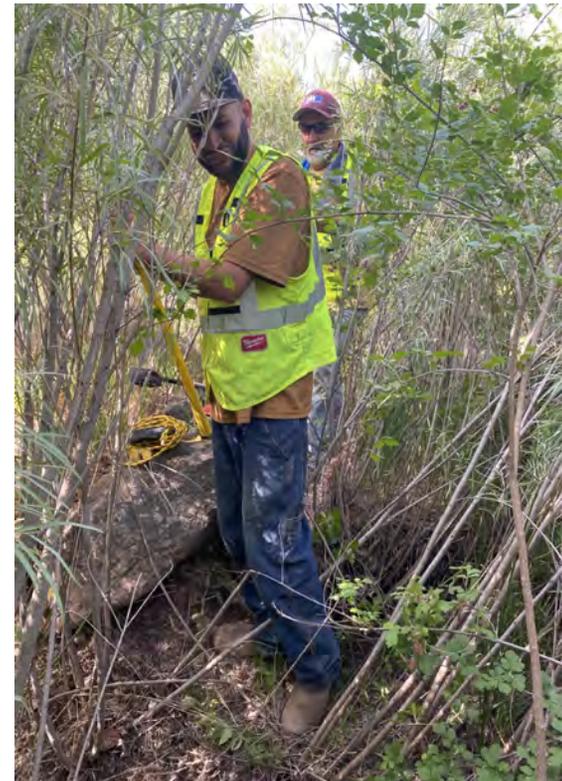
Manhole in thick willows on the river overbank, heavily corroded rim - can't open
---

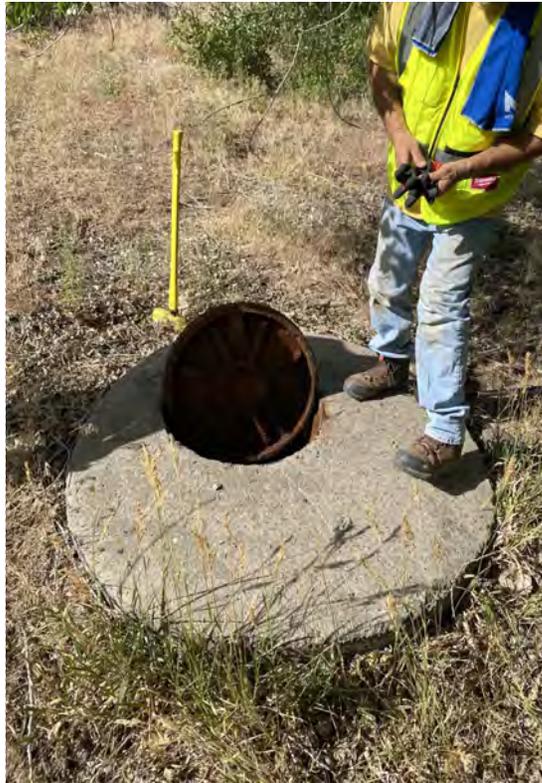
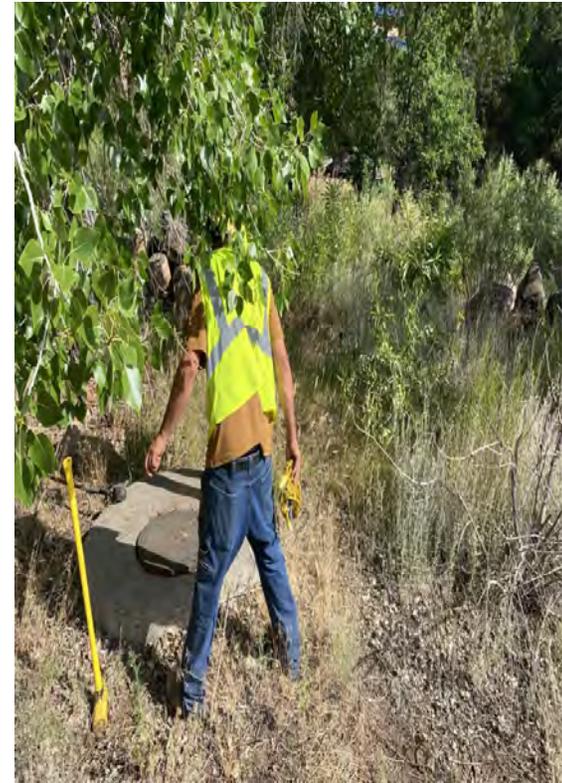
Manhole ID	42
Inspection Date & Time	07/19/2023 3:06pm
Rim Elevation	
Invert Depth	
Invert Elevation	56.00

Heavy corrosion, I&I (clear water steady stream)

Location	Other
Manhole Cover	Corroded
Ring & Frame	Corroded
Manhole Material	Brick
Manhole Size	4 foot

Vermin	Roaches
Steps	Corroded
Cone	Corroded
Riser	Corroded
Shelf	Dirty
Channel	Corroded

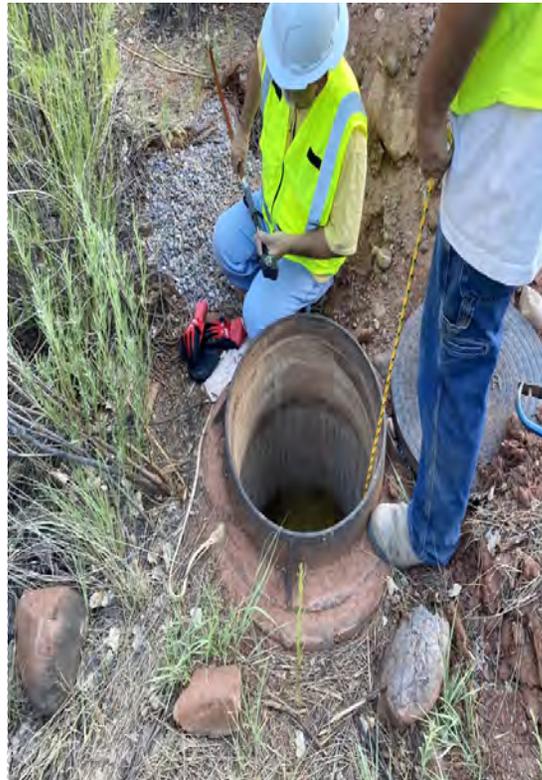
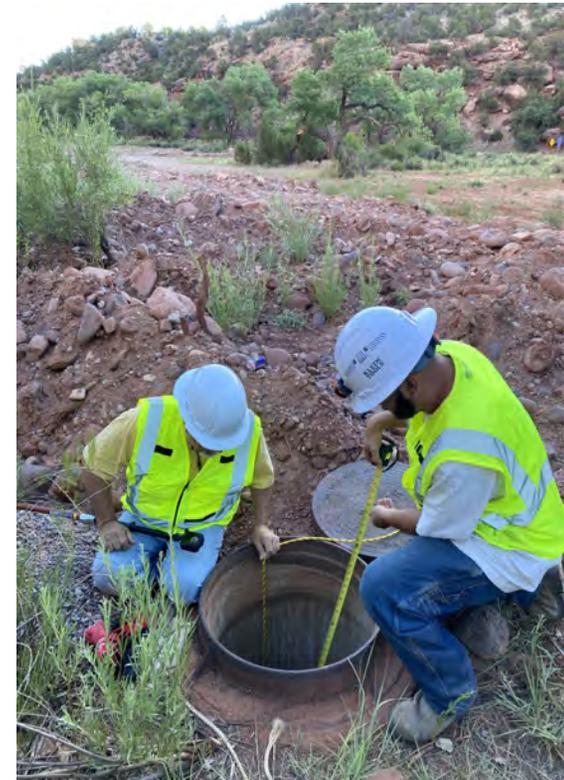
Buildup in channel, needs bollards
------------------------------------

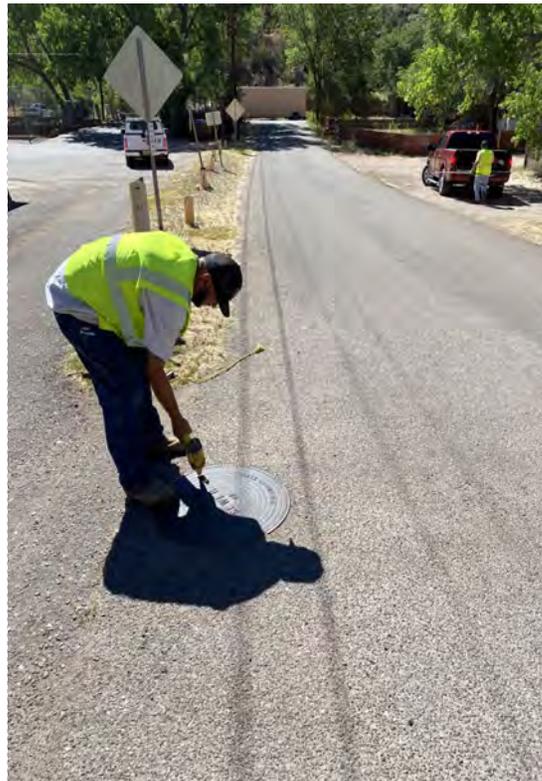
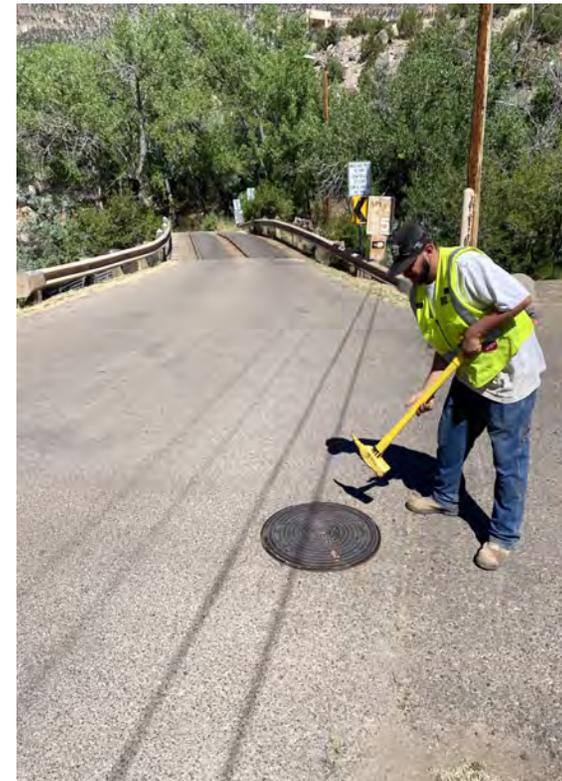
Manhole ID	52
Inspection Date & Time	07/17/2023 4:28pm
Rim Elevation	
Invert Depth	
Invert Elevation	86.00

Location	Roadway
Manhole Cover	Corroded
Ring & Frame	Corroded
Manhole Material	Concrete
Manhole Size	4 foot

Vermin	
Steps	Corroded
Cone	Corroded
Riser	Corroded
Shelf	Corroded
Channel	Corroded

Fast flow
-----------

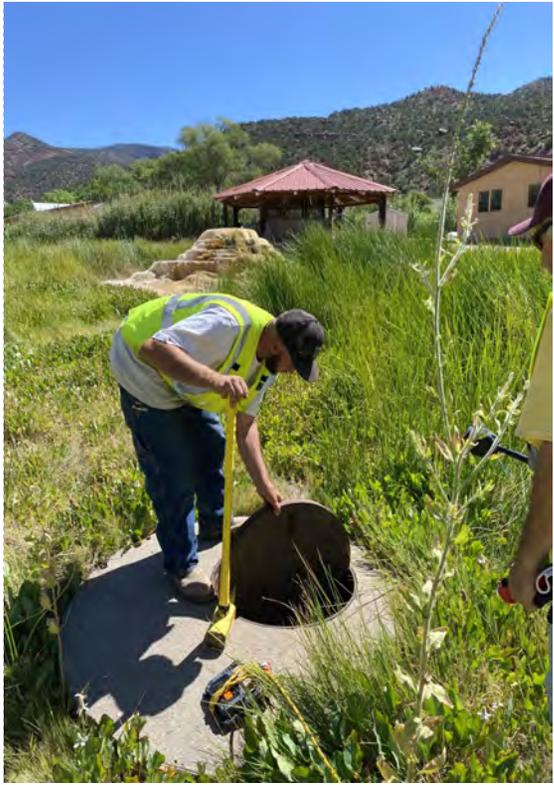
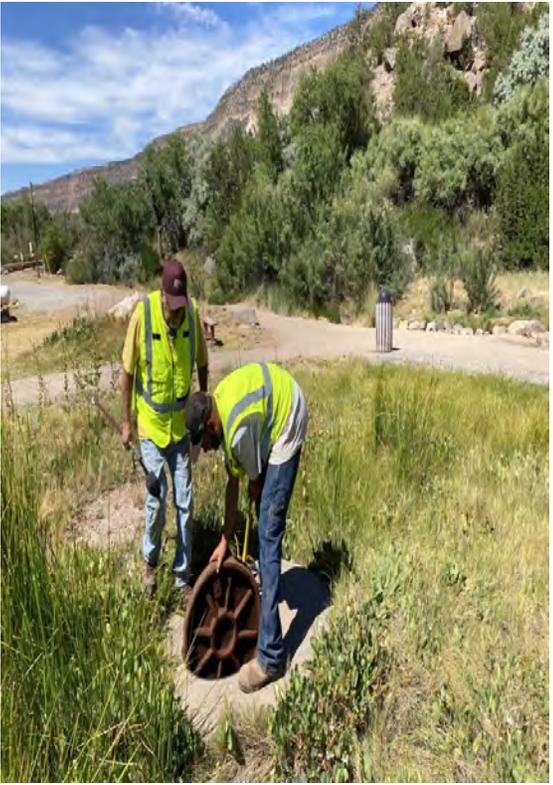
Manhole ID	52A
Inspection Date & Time	07/17/2023 4:48pm
Rim Elevation	
Invert Depth	
Invert Elevation	58.00

Location	Other
Manhole Cover	Corroded
Ring & Frame	Missing Grout
Manhole Material	Concrete
Manhole Size	4 foot

Vermin	
Steps	Corroded
Cone	Corroded
Riser	Corroded
Shelf	Corroded
Channel	Obstructed

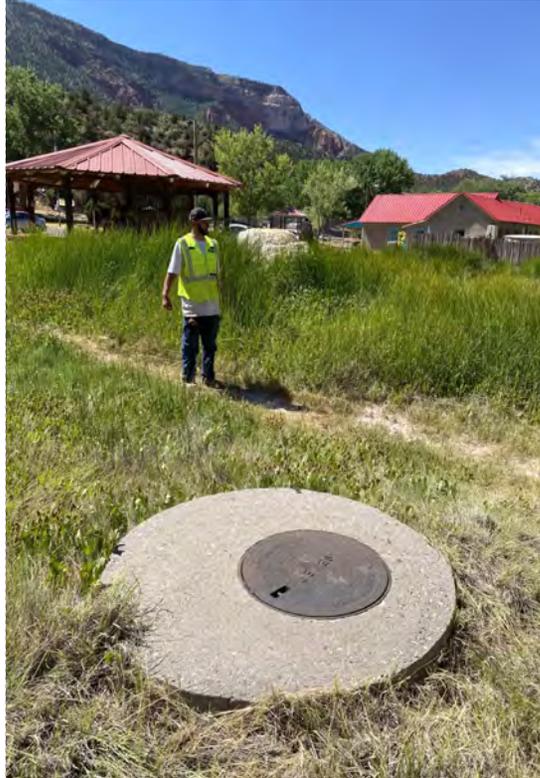
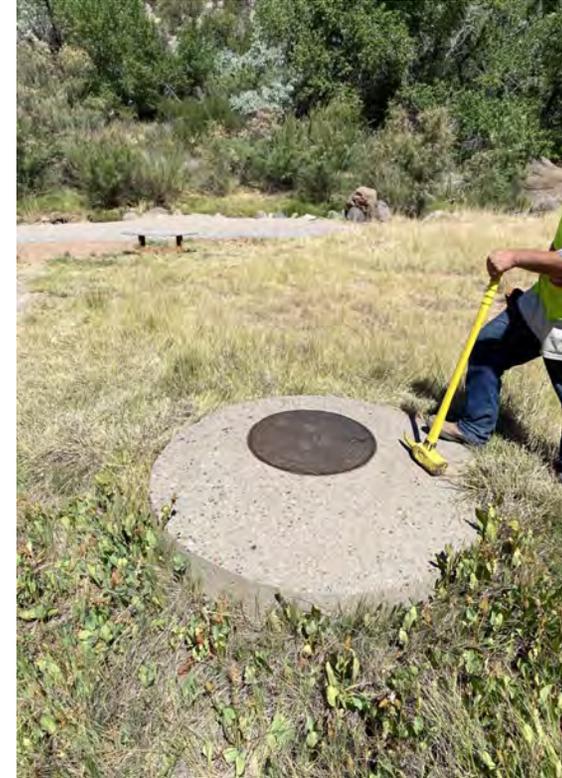
Manhole ID	53
Inspection Date & Time	07/17/2023 4:53pm
Rim Elevation	
Invert Depth	
Invert Elevation	60.00

Location	Other
Manhole Cover	Corroded
Ring & Frame	Corroded
Manhole Material	Concrete
Manhole Size	4 foot

Vermin	
Steps	Corroded
Cone	Corroded
Riser	Corroded
Shelf	Corroded
Channel	Corroded

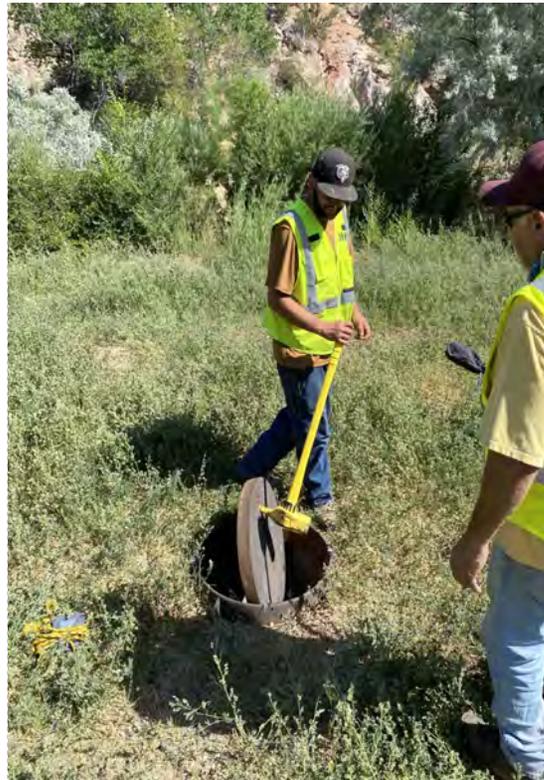
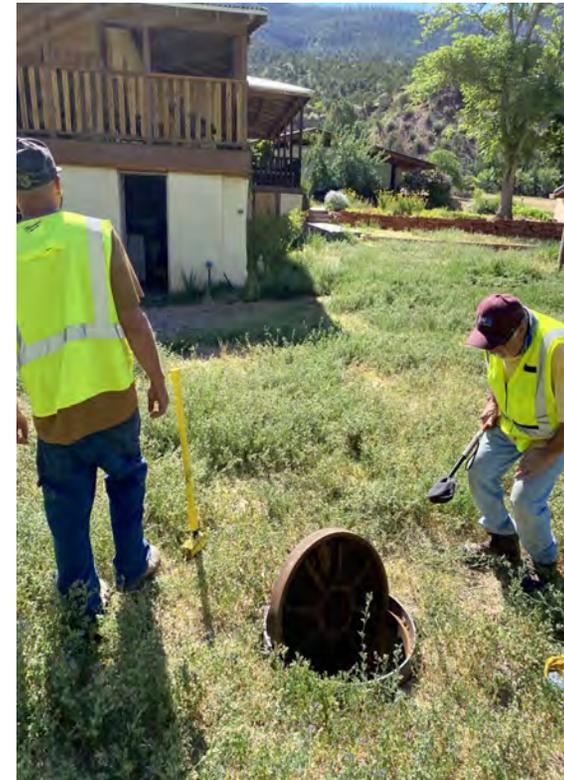
Vermin	
Steps	Corroded
Cone	Serviceable
Riser	Serviceable
Shelf	Serviceable
Channel	Corroded

Debris in channel
-------------------

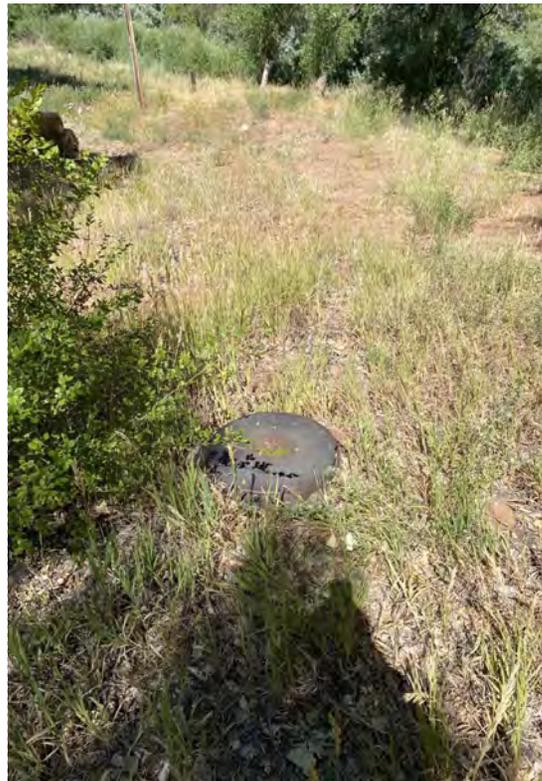
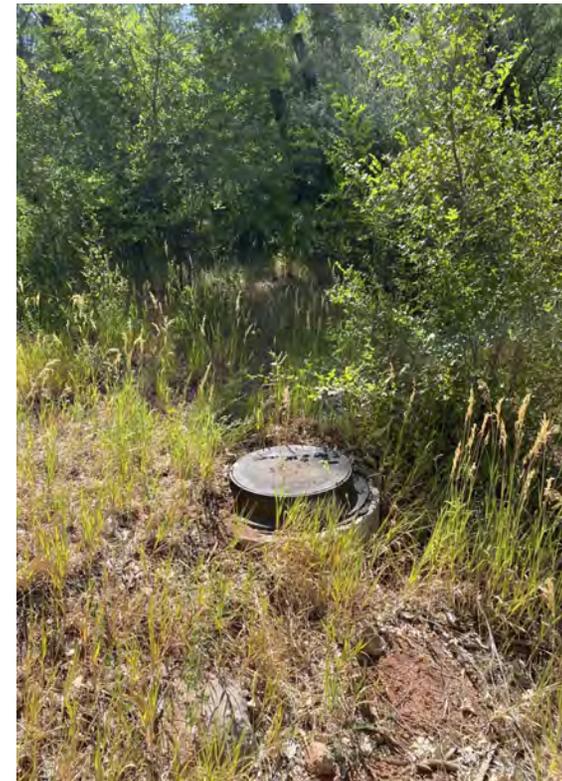
Manhole ID	55
Inspection Date & Time	07/19/2023 4:24pm
Rim Elevation	
Invert Depth	
Invert Elevation	99.00

Vermin	
Steps	Corroded
Cone	Serviceable
Riser	Serviceable
Shelf	Dirty
Channel	Silt

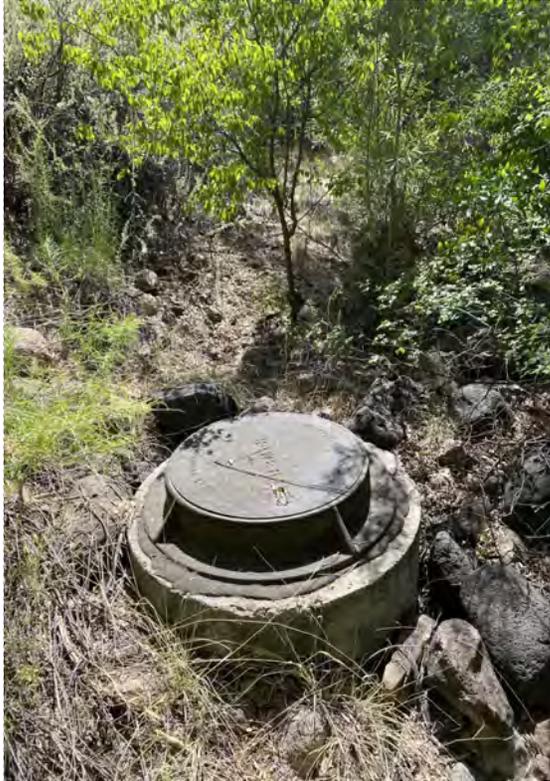
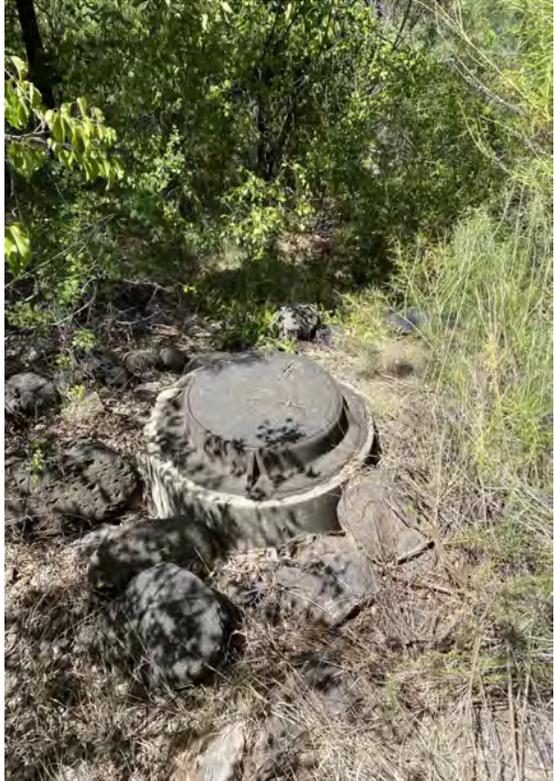
Vermin	
Steps	Corroded
Cone	Serviceable
Riser	Serviceable
Shelf	Serviceable
Channel	Obstructed

Not flowing, stoppage in channel

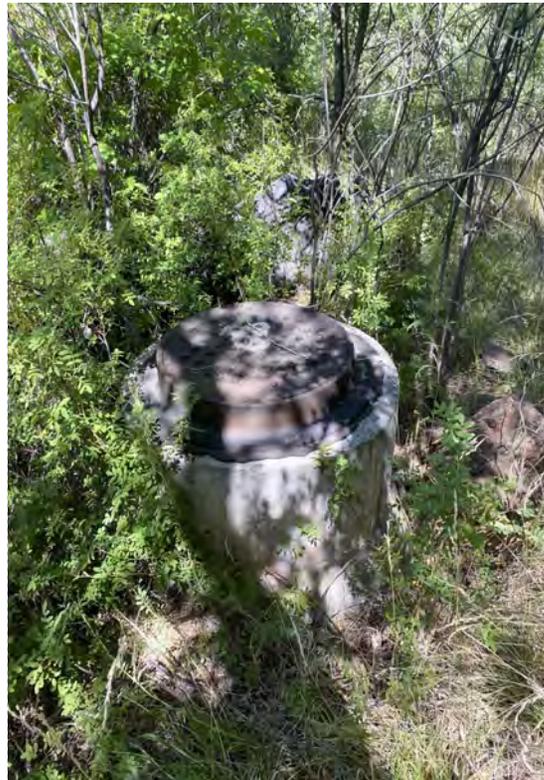
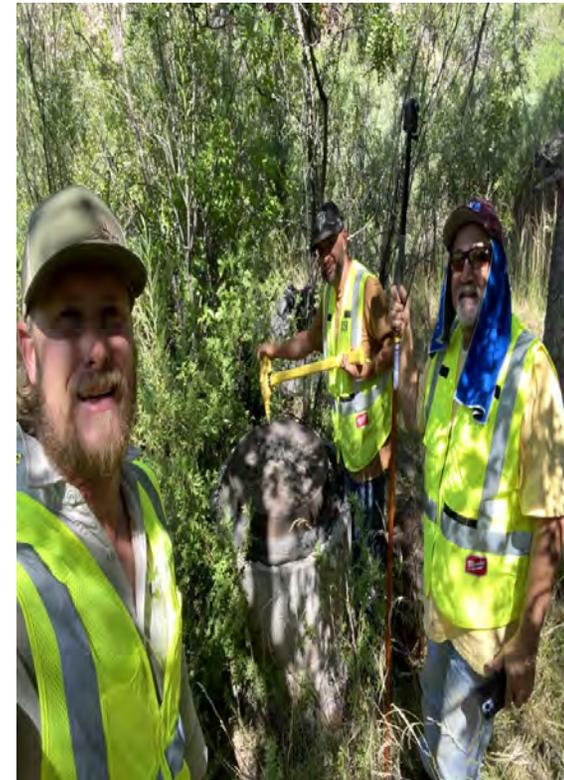
Manhole ID	62
Inspection Date & Time	07/19/2023 5:06pm
Rim Elevation	
Invert Depth	
Invert Elevation	97.00

Vermin	
Steps	Corroded
Cone	Serviceable
Riser	Serviceable
Shelf	Serviceable
Channel	Silt

Rim 2 feet above grade, debris in channel
---

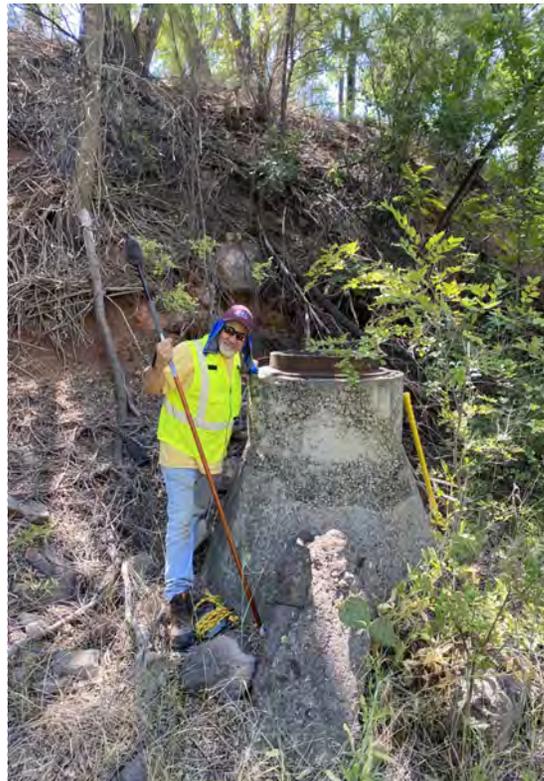
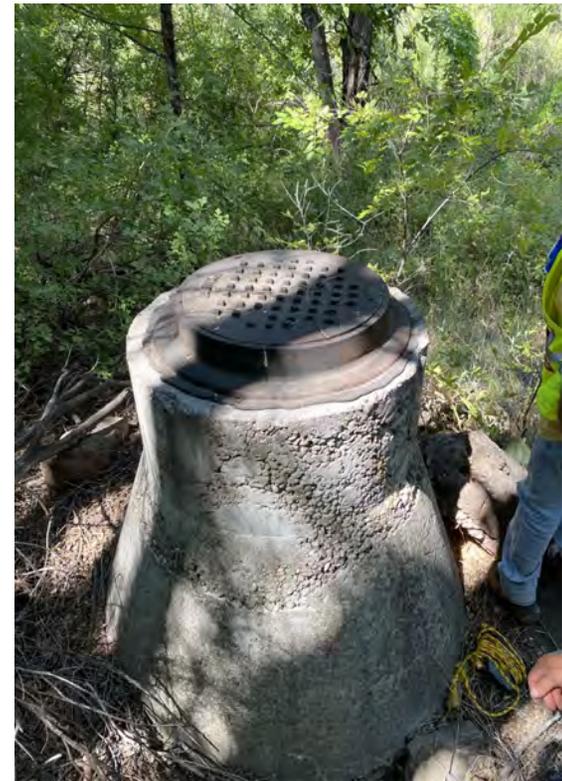
Manhole ID	63
Inspection Date & Time	07/19/2023 4:56pm
Rim Elevation	
Invert Depth	
Invert Elevation	149.00

Rim is 5 feet above grade, debris in channel
--

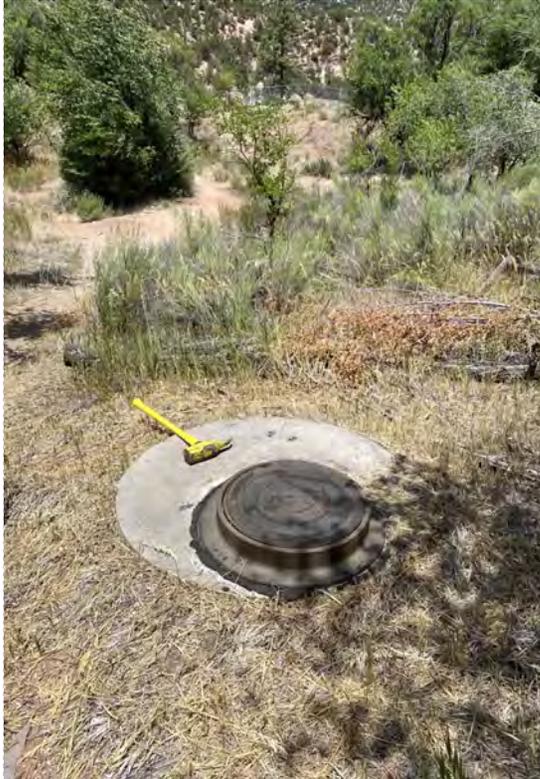
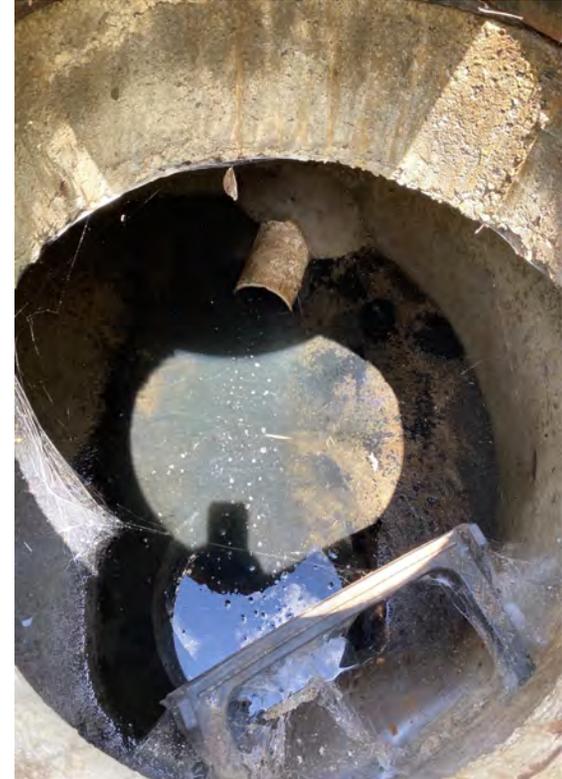
Full of water, outlet underwater, inlet 75% covered, black sludge material

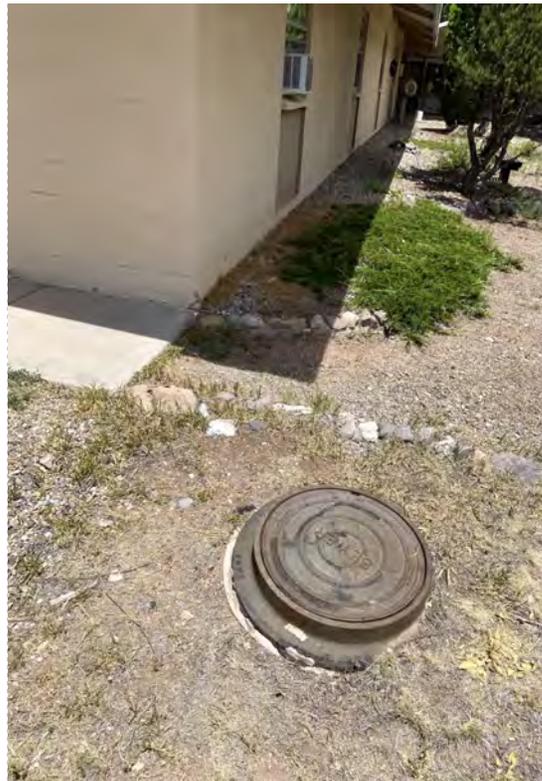
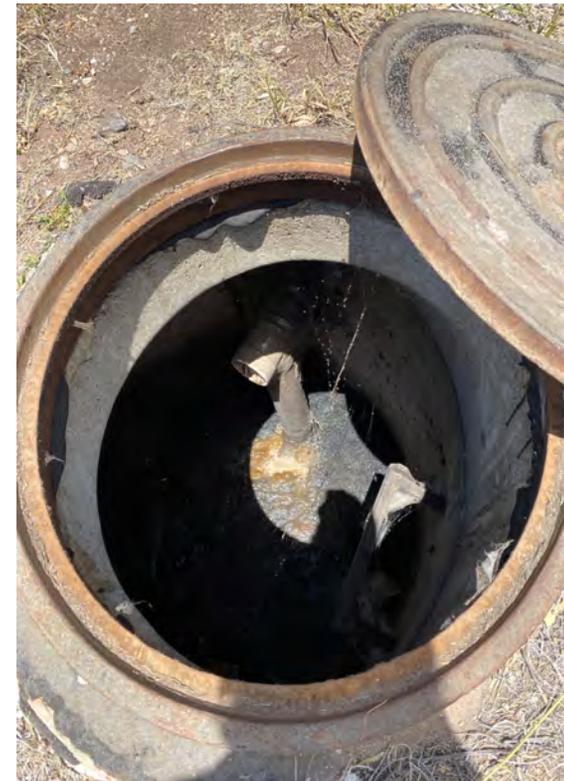
Vermin	
Steps	Corroded
Cone	Serviceable
Riser	Serviceable
Shelf	Other
Channel	Other

Completely backed up with sludge, grease trap next to MH and may be connected

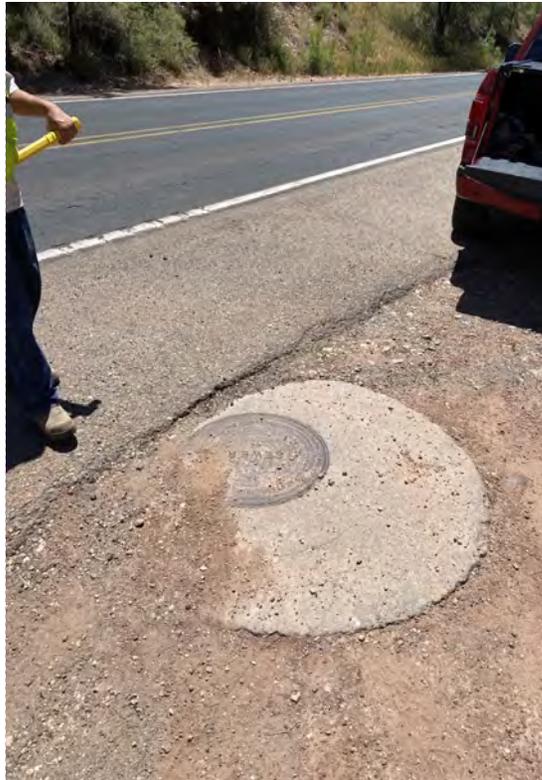
Vermin	
Steps	Corroded
Cone	Serviceable
Riser	Serviceable
Shelf	Dirty
Channel	Obstructed

Debris in channel, blockage (no flow) - standing water.

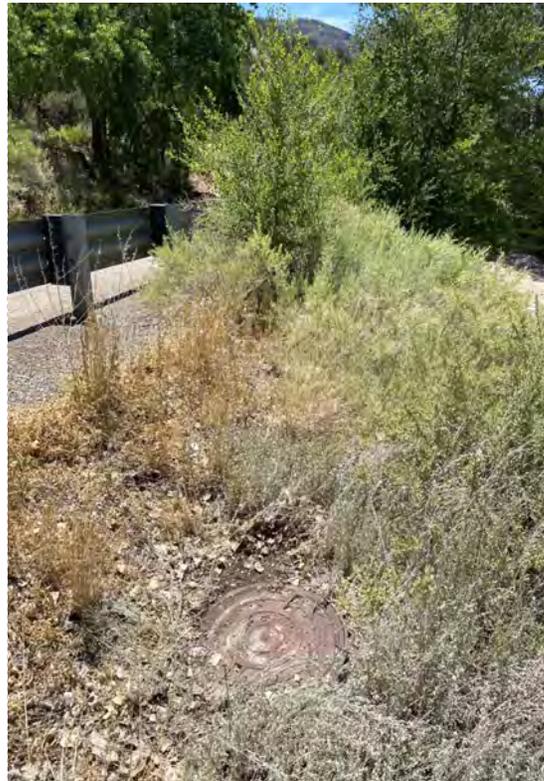
Vermin	
Steps	Corroded
Cone	Serviceable
Riser	Serviceable
Shelf	Dirty
Channel	Obstructed

Inflow Indications	Debris on sides/shelf
Surcharge Indications	
Clarity of Flow	Other
Flow	None
Flow Depth Compared to Adjacent Manholes	Lower
FlowDepth_in	0.00

Dirty and no flow. buildup on shelf and channel.
--

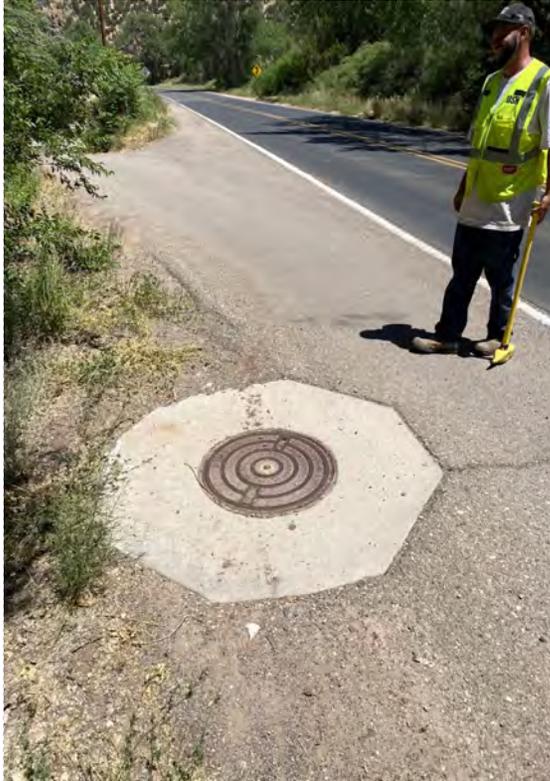
Vermin	
Steps	Corroded
Cone	Serviceable
Riser	Serviceable
Shelf	Dirty
Channel	Obstructed

No flow, pipes 90% blocked and full of dirt

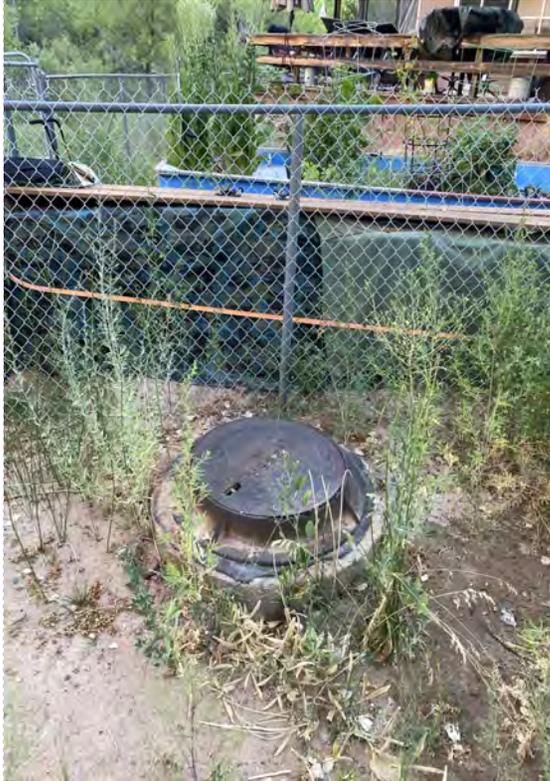
Vermin	
Steps	Corroded
Cone	Serviceable
Riser	Serviceable
Shelf	Dirty
Channel	Corroded

Clear steady flow, I&I

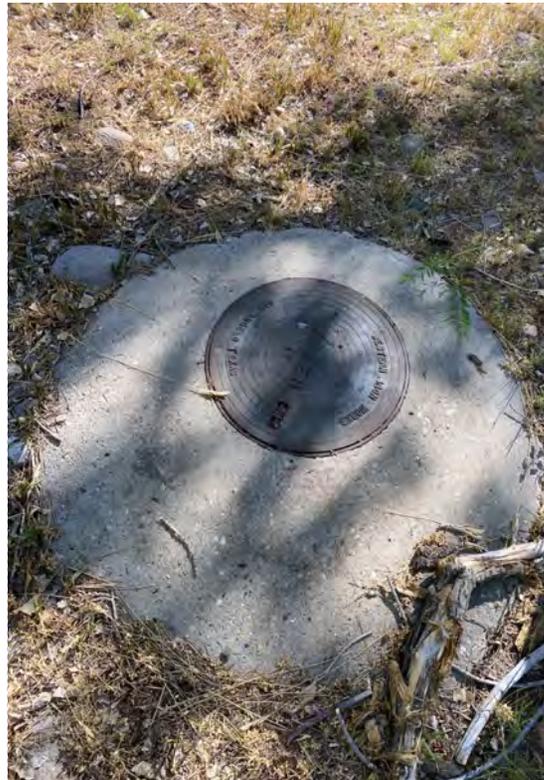
Drop inlet. Lots of water - infiltration upstream
---

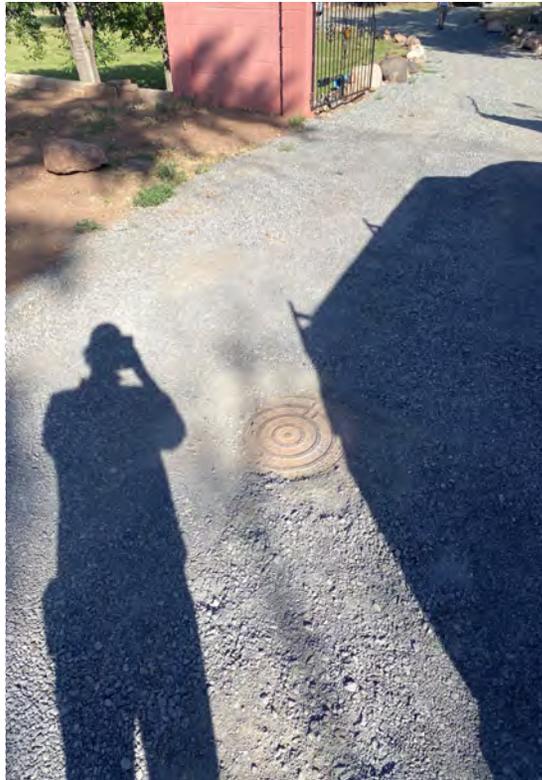
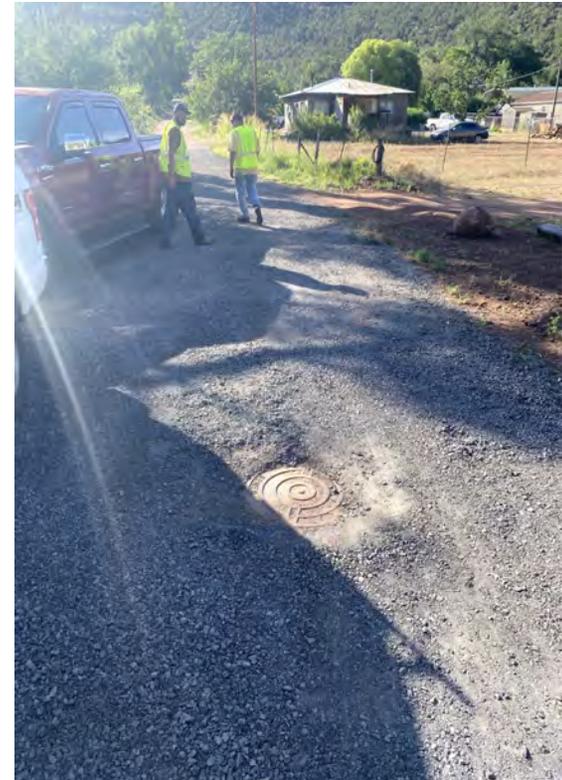
Vermin	
Steps	Corroded
Cone	Corroded
Riser	Leaking/bad joints
Shelf	Dirty
Channel	Obstructed

Large roots, heavy buildup on channel and shelf, pipes 25% blocked
