# Preliminary Engineering Report

## Wastewater System Improvements

### Village of Jemez Springs, New Mexico

February 2, 2024

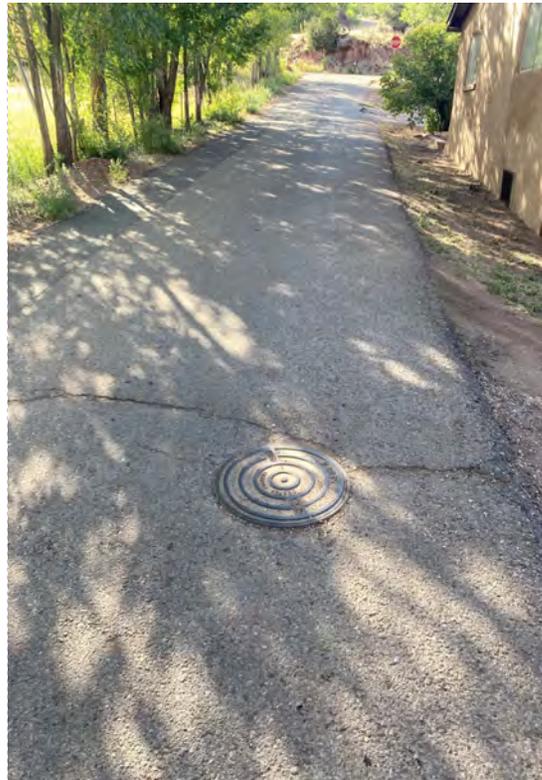
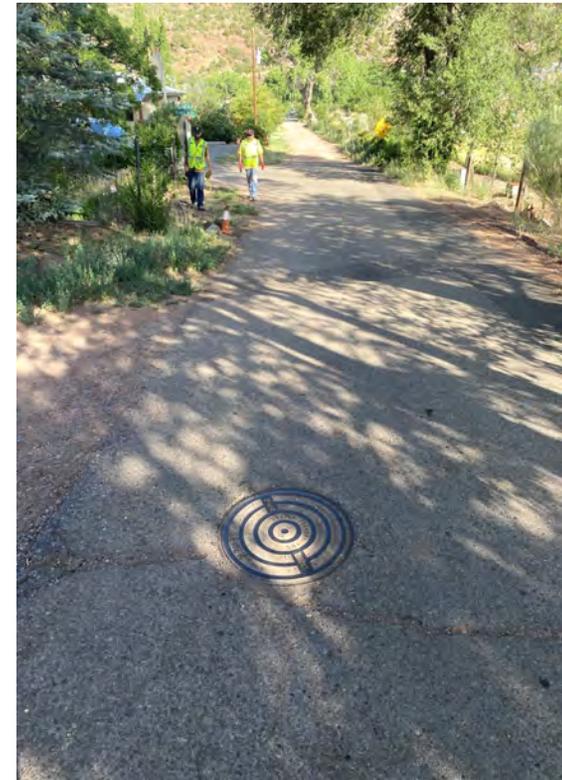
Vermin	Roaches
Steps	Corroded
Cone	Serviceable
Riser	Serviceable
Shelf	Dirty
Channel	Obstructed

Debris buildup in channel
---------------------------

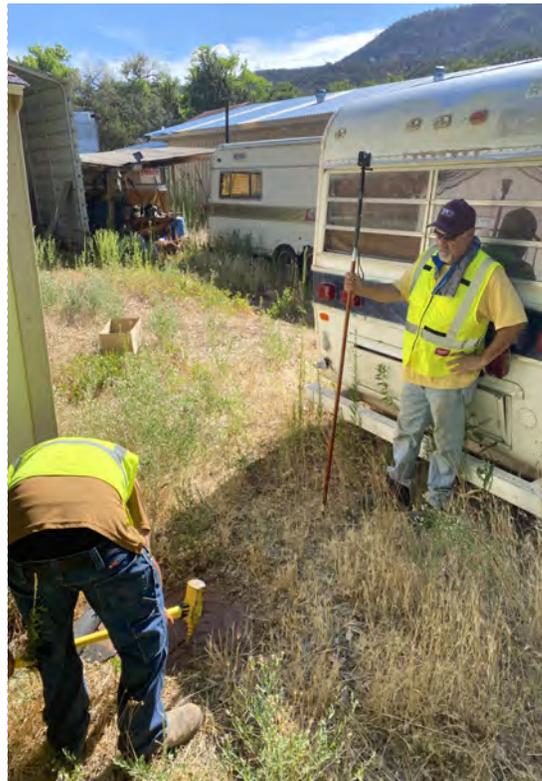
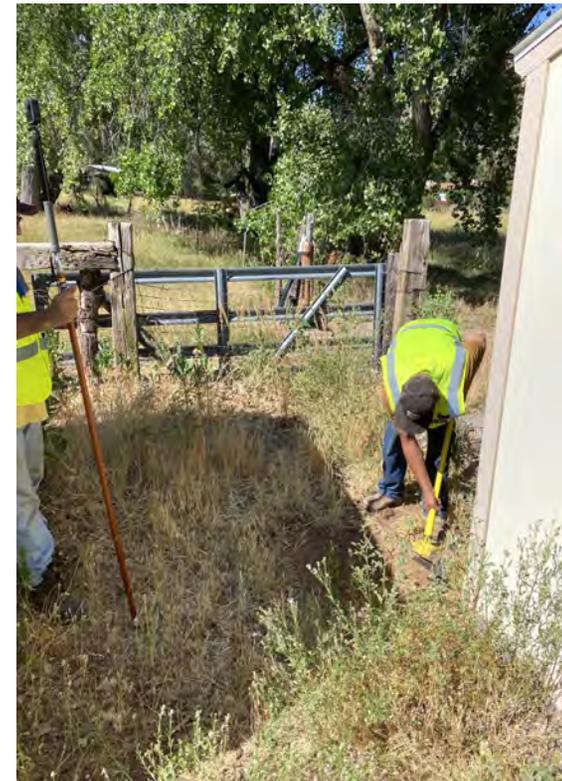
Vermin	
Steps	Corroded
Cone	Serviceable
Riser	Serviceable
Shelf	Dirty
Channel	Obstructed

Debris, pipes 10% blocked
---------------------------

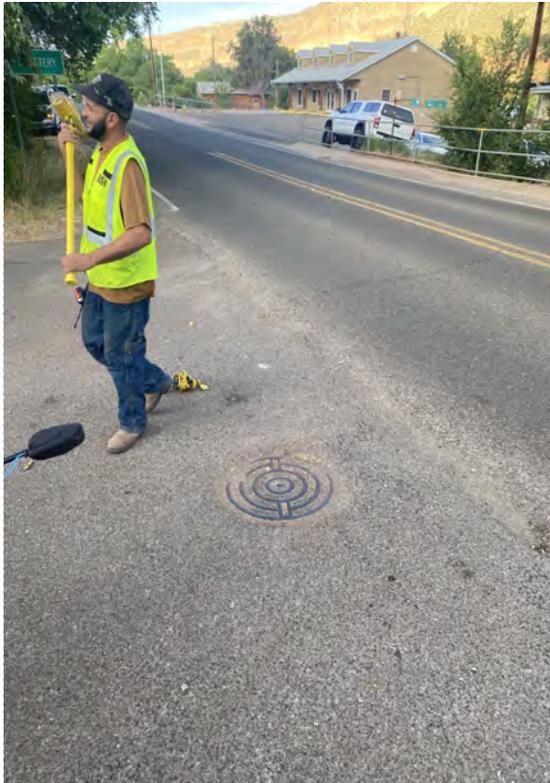
Vermin	Roaches
Steps	Corroded
Cone	Serviceable
Riser	Corroded
Shelf	Dirty
Channel	Obstructed

Foot of buildup, plugged not flowing

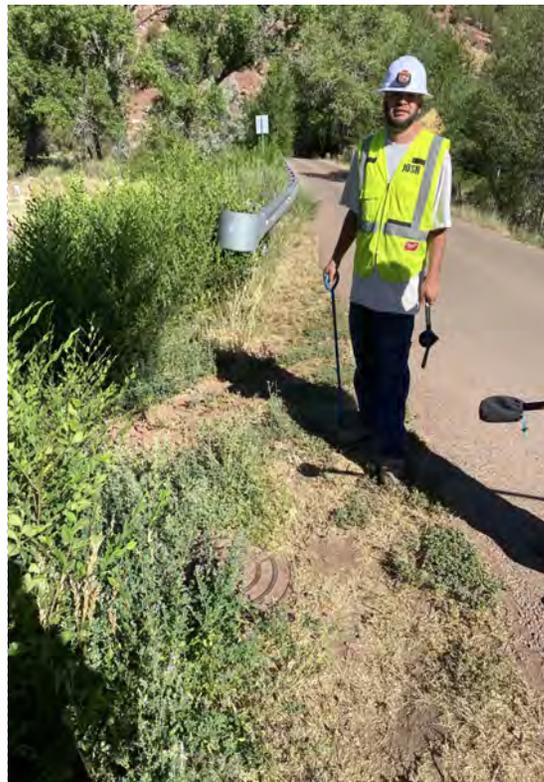
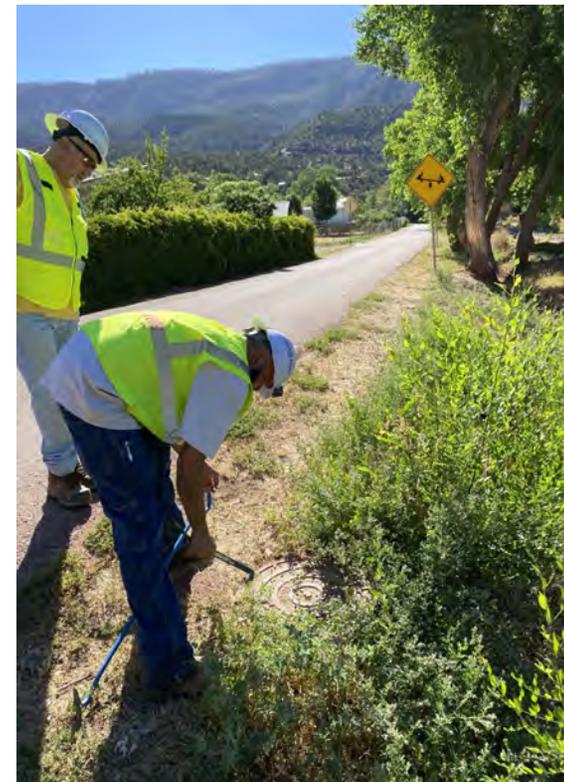
Vermin	
Steps	Corroded
Cone	Serviceable
Riser	Corroded
Shelf	Dirty
Channel	Obstructed

2 inlets, dirty channel, corroded rim and riser
---

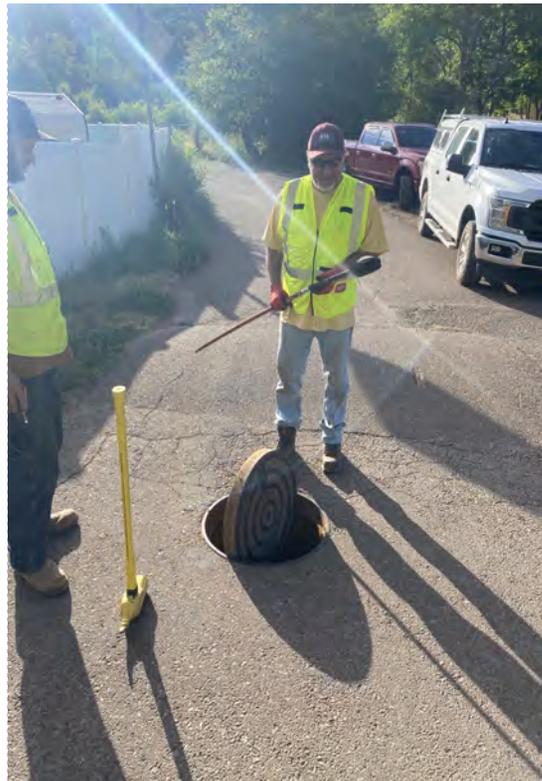
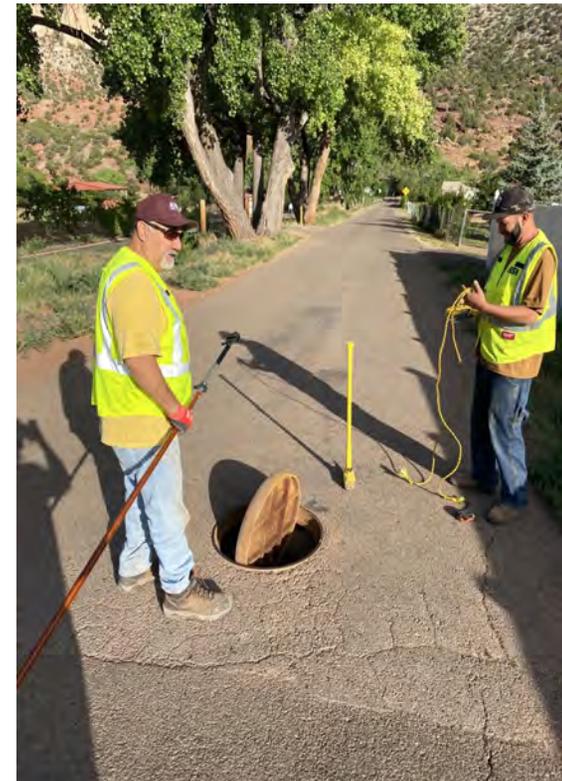
Vermin	Roaches
Steps	Corroded
Cone	Serviceable
Riser	Serviceable
Shelf	Dirty
Channel	Silt

Outlet pipe 25% buildup, slowing flow
---------------------------------------

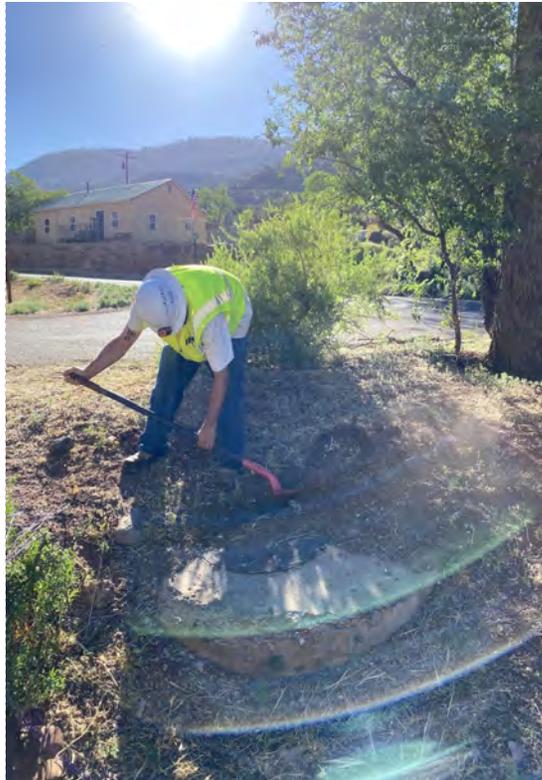
Location	Roadway
Manhole Cover	Serviceable
Ring & Frame	Missing Grout
Manhole Material	Concrete
Manhole Size	4 foot

No flow, discharge pipe buried and full of dirt

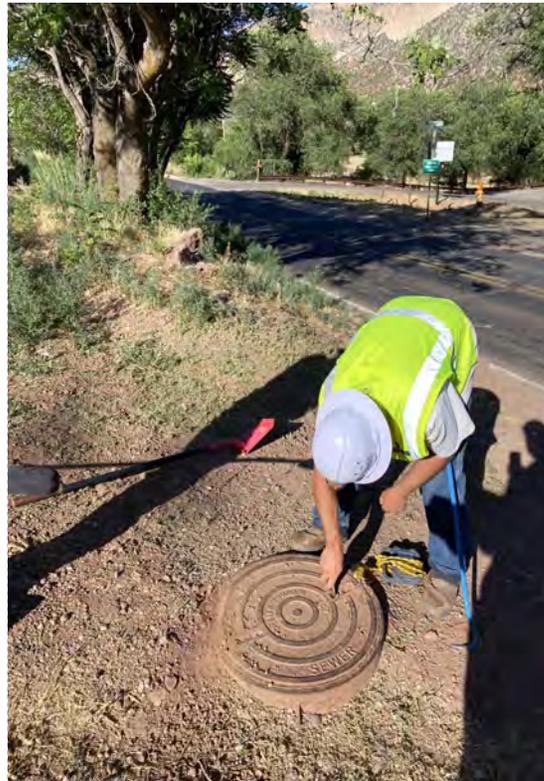
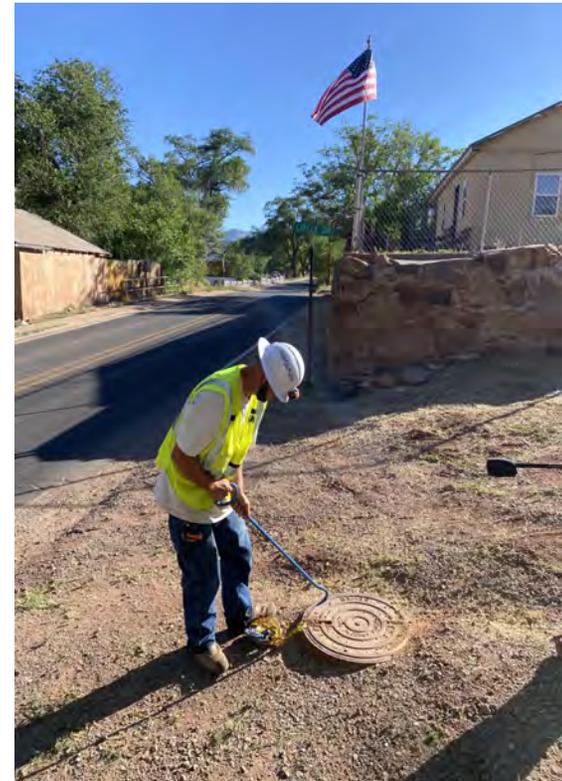
Location	Roadway
Manhole Cover	Serviceable
Ring & Frame	Corroded
Manhole Material	Concrete
Manhole Size	4 foot

No flow (dry), corroded rim, drop manhole
---

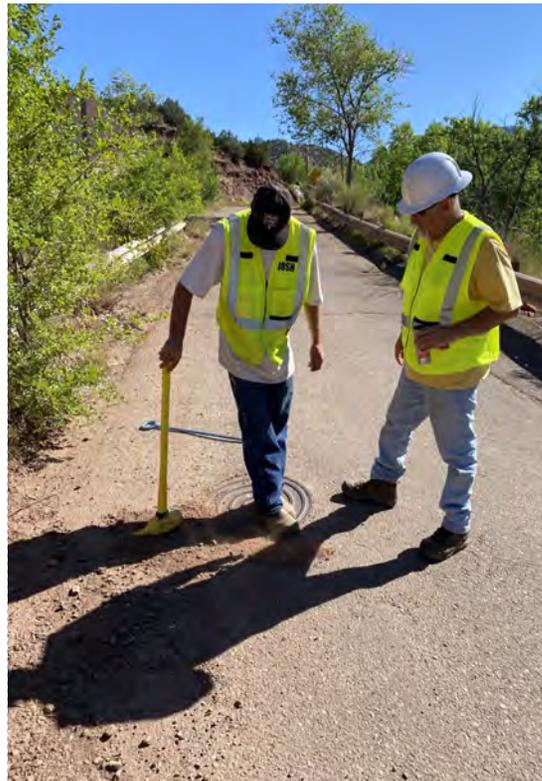
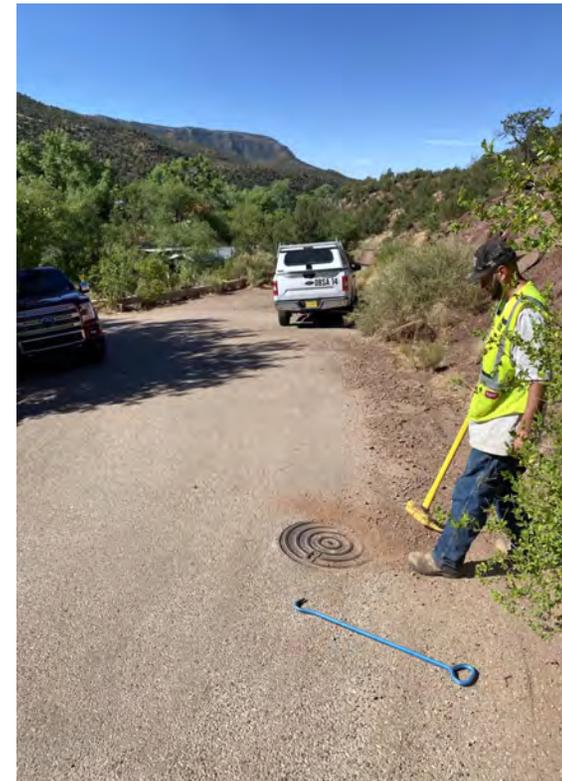
Location	Roadway
Manhole Cover	Corroded
Ring & Frame	Serviceable
Manhole Material	Concrete
Manhole Size	4 foot

Vermin	
Steps	Corroded
Cone	Corroded
Riser	Misaligned
Shelf	Dirty
Channel	Silt

Foot of dirt on the shelf. Shallow. Lots of buildup.

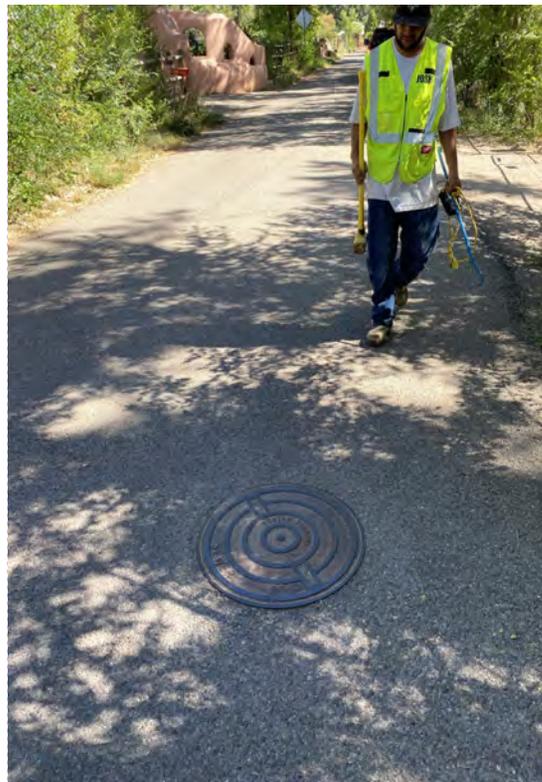
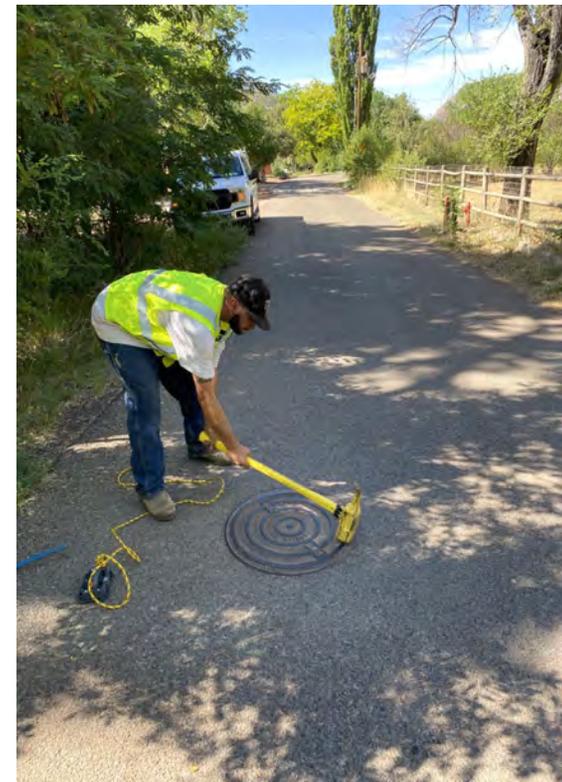
Vermin	
Steps	Corroded
Cone	Corroded
Riser	Corroded
Shelf	Dirty
Channel	Obstructed

Foot of buildup on shelf. Corroded cover, ring and frame.

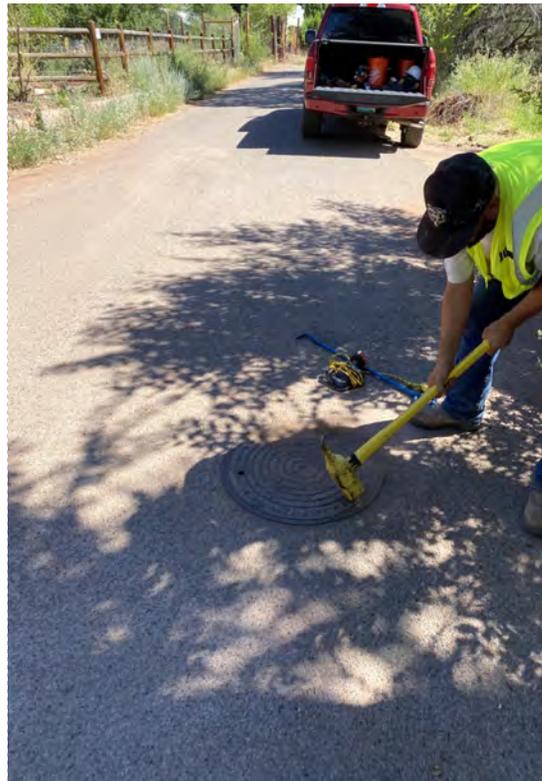
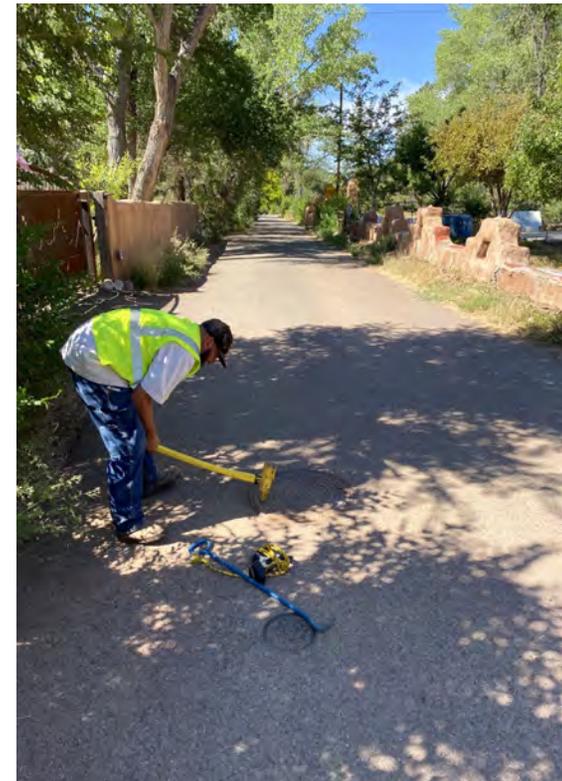
### Pictures

2" inlet. Corroded cover, ring, and frame.

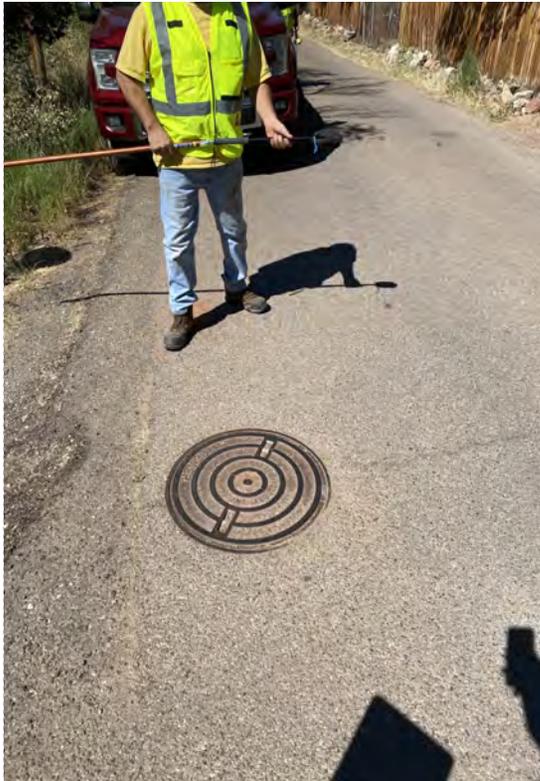
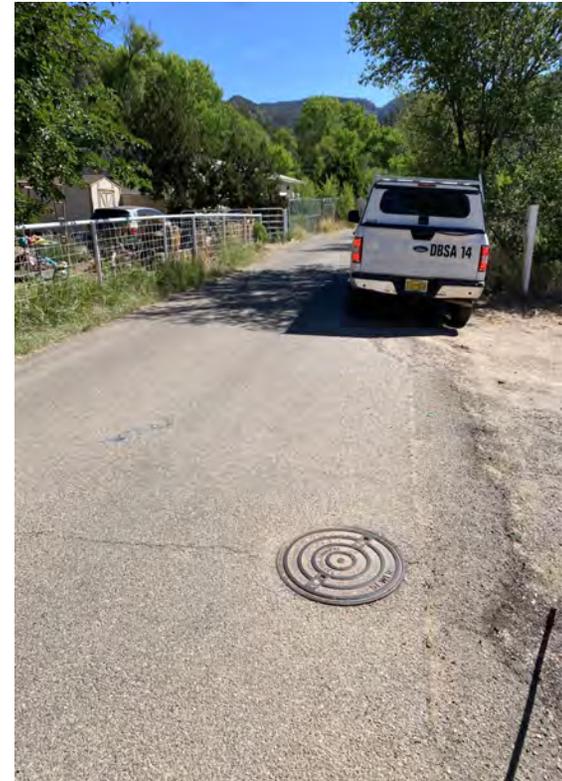
#### Pictures

Standing water/no flow. debris in channel - downstream impedences. Corroded rim and cover.

Location	Roadway
Manhole Cover	Corroded
Ring & Frame	Corroded
Manhole Material	
Manhole Size	4 foot

Vermin	
Steps	Corroded
Cone	Serviceable
Riser	
Shelf	Dirty
Channel	Obstructed

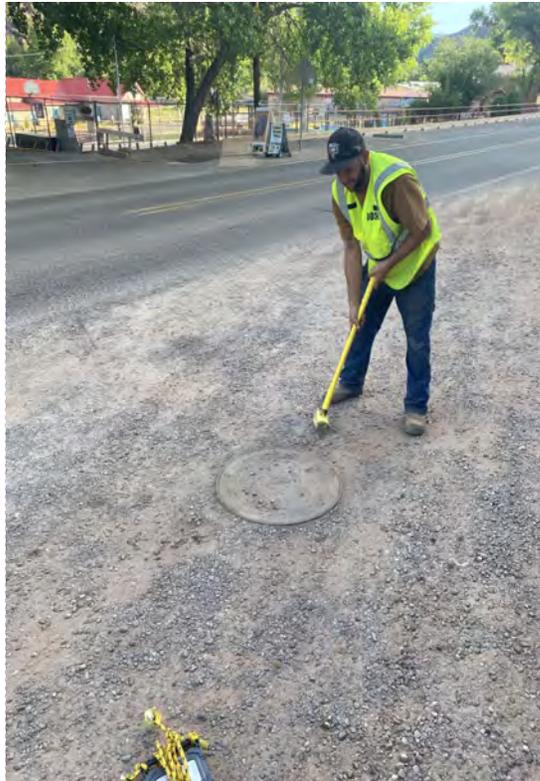
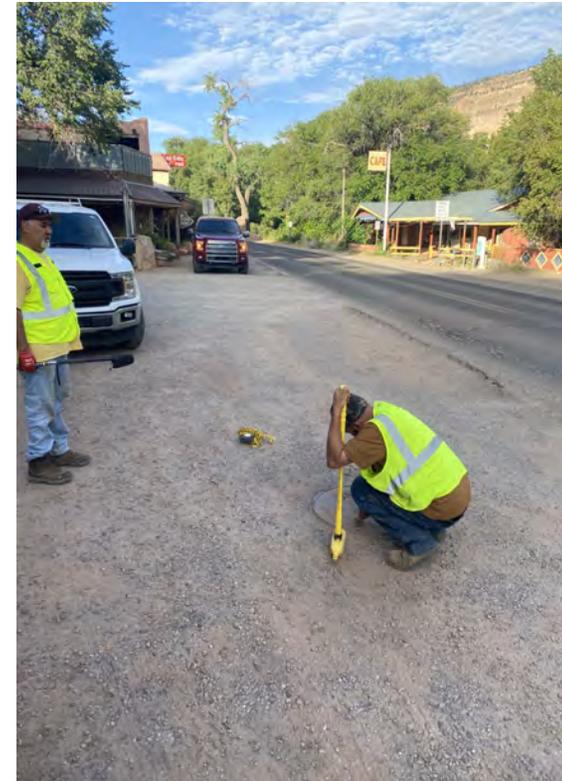
### Pictures

Vermin	Roaches
Steps	Corroded
Cone	Corroded
Riser	Serviceable
Shelf	Dirty
Channel	Obstructed

Dirt, buildup, outlet goes under the road

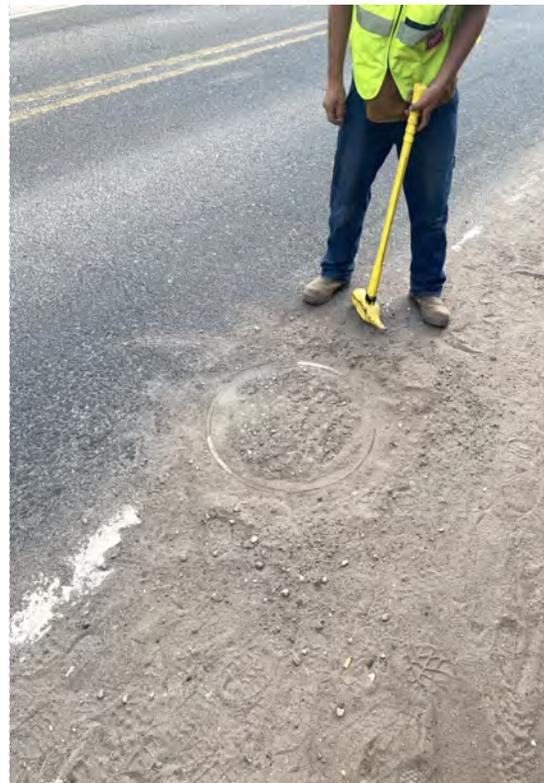
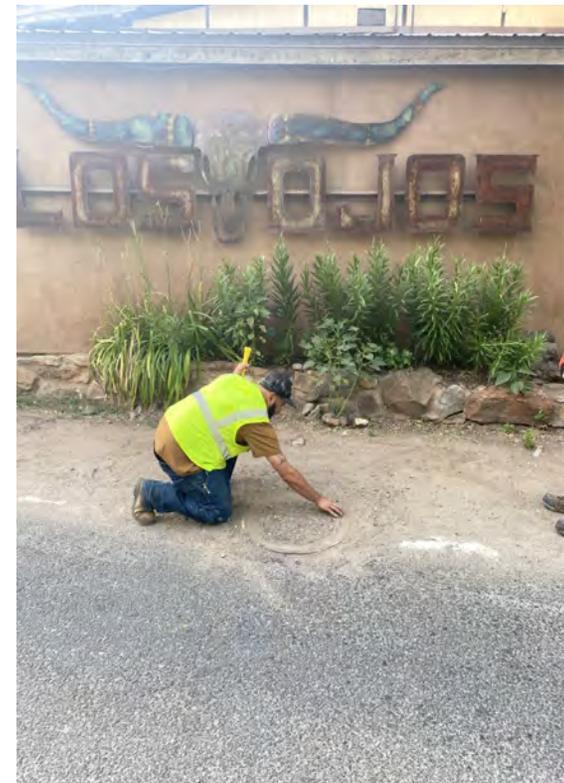
### Pictures

Location	Roadway
Manhole Cover	Serviceable
Ring & Frame	Corroded
Manhole Material	Concrete
Manhole Size	4 foot

Vermin	
Steps	Corroded
Cone	Serviceable
Riser	Serviceable
Shelf	Dirty
Channel	Obstructed

Dirty, low flow
-----------------

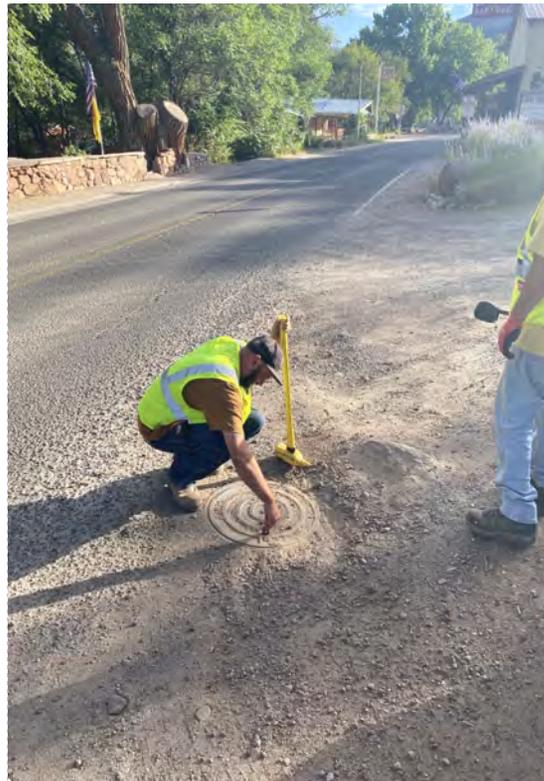
### Pictures

Location	Roadway
Manhole Cover	Corroded
Ring & Frame	Corroded
Manhole Material	Concrete
Manhole Size	4 foot

Vermin	Roaches
Steps	Corroded
Cone	Corroded
Riser	Serviceable
Shelf	Dirty
Channel	Obstructed

Pipe 50% obstructed, slow flow
--------------------------------

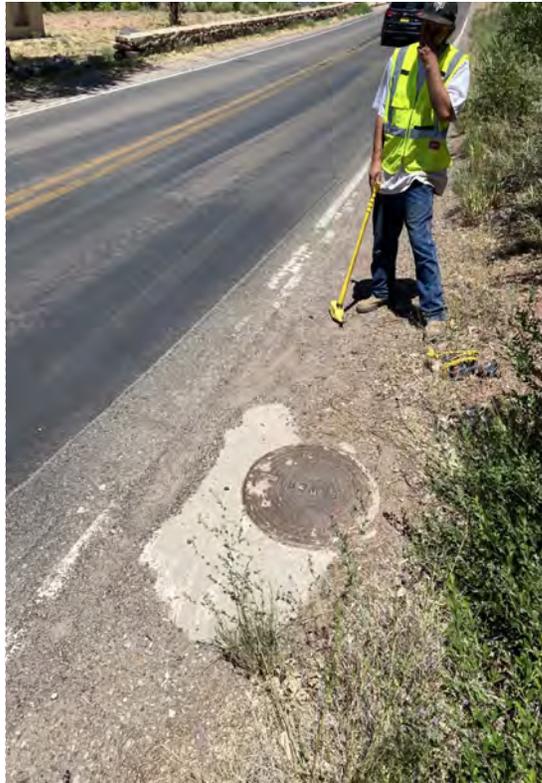
Pictures

Vermin	
Steps	Corroded
Cone	Serviceable
Riser	Serviceable
Shelf	Dirty
Channel	Obstructed

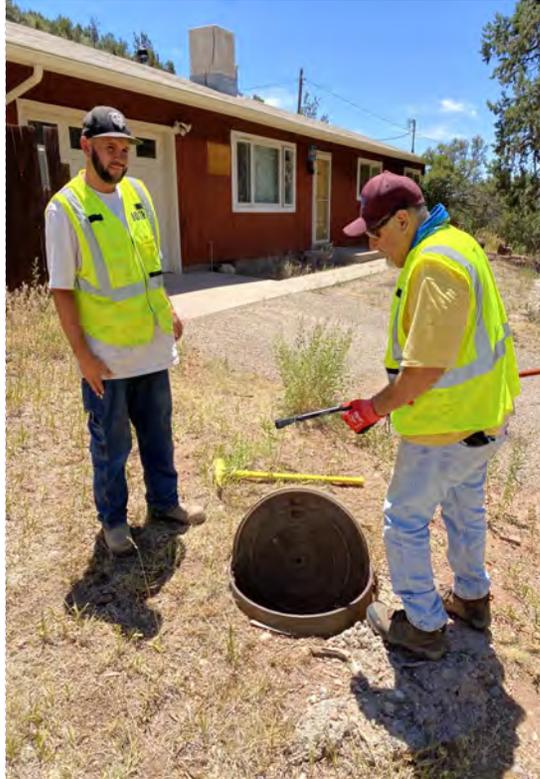
### Pictures

Vermin	
Steps	Corroded
Cone	Serviceable
Riser	Serviceable
Shelf	Serviceable
Channel	Silt

No water - manhole is dry and has dirt buildup.

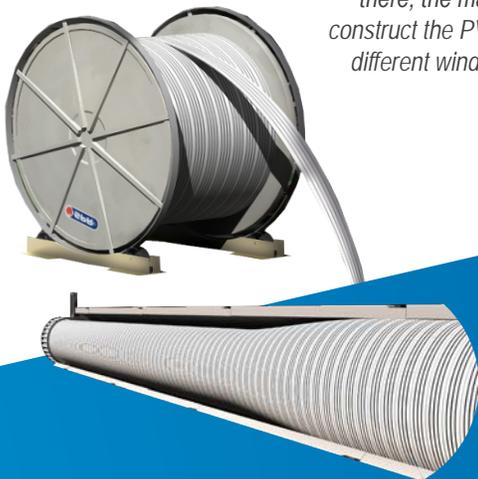
# INSTALLATIONS

*For installations, a continuous strip of PVC is fed from a spool above ground into the winding machine. From there, the machine continuously winds the profile to construct the PVC liner within the host pipe. We offer 3 different winding methods based upon the host pipe.*

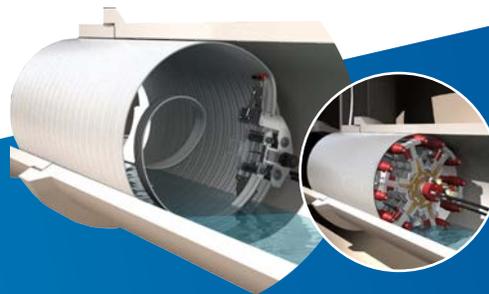
## SPR™EX | 6" - 42"

The SPR™EX liner is formed by a static machine that pushes the liner from access chamber to access chamber. A wire within the liner is then pulled, severing a secondary lock. This expands the PVC liner to fit tightly against the host pipe, requiring no annular space grouting.

SPR™EX is a stationary installation process. The equipment pushes the wound PVC liner from access chamber to access chamber.

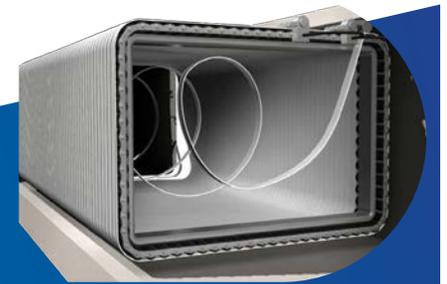
## SPR™TF | 40" - 60"

SPR™TF is a tight-fitting liner that does not require annular space grouting. Profile is fed into a traverse winding machine which forms a continuous liner between access points.

SPR™TF features 2 different winding machines depending on the project; a lightweight, compact machine or one featuring rotating hydraulic arms. Both machines traverse the pipeline while constructing a tight-fit liner.

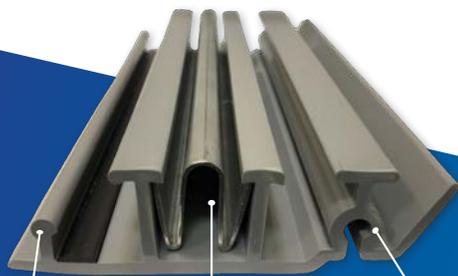
## PVC PROFILE

Male Lock    Optional Steel Reinforcement    Female Lock

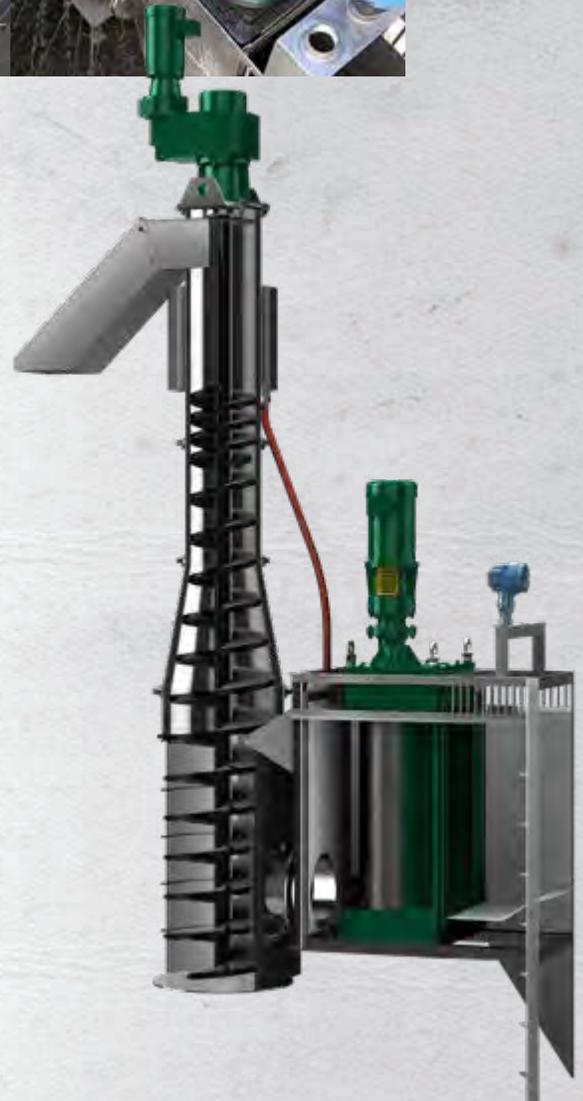
The Vertical Auger Monster is a fine screening device that captures debris, conveys it vertically out of the pump station, launders the screenings to remove fecal matter and finally dewater the debris before depositing the clean and dry material into a bin. When paired with a dual-shafted JWC Monster Grinder, the cleanliness of the screenings is maximized. The grinder breaks up rags and tough solids allowing for a higher level of separation of the organics from the solids.

JWC Environmental offers a selection of Vertical Auger Monster products to serve a wide range of applications. The **ACV** and **AGV Vertical Auger Monsters** incorporate Muffin Monster® grinding technology and have peak flows up to 4.8 mgd (759 m<sup>3</sup>/hr). The **ALV Vertical Auger Monster** is a cost-effective solution with the capability of flows as high as 9.4 mgd (1474 m<sup>3</sup>/hr).

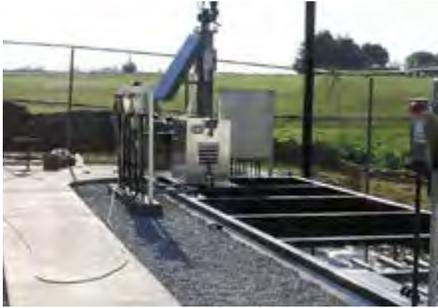
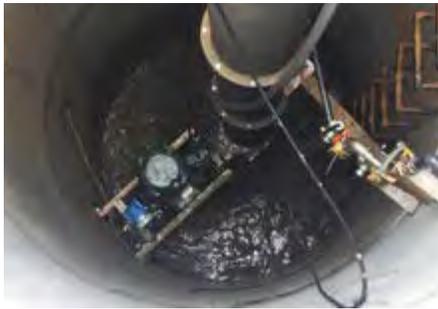
## ALV Vertical Auger Monster®

The ALV Vertical Auger Monster is for applications with lower solids loading and high flows. This cost-effective solution captures, conveys and dewater debris utilizing a rugged dual-helix auger to compact and dewater the solids. This version can handle peak flows up to 9.4 mgd (1474 m³/hr).

ALV Model	Max pipe size - inch (mm)	Standard dimensions - inch (mm)			Wall mount dimensions - inch (mm)		Round wall mount dimensions - inch (mm)		Max flow* - mgd (m³/hr)		
		A	B	C	D	E	F	G	0% Blind	30% Blind	50% Blind
ALV1801-285	12 (300)	38-1/4 (972)	27-1/2 (699)	3-1/2 (89)	55-5/8 (1413)	46 (1168)	61-9/16 (1564)	17-15/16 (456)	2.06 (324)	1.44 (227)	1.03 (162)
ALV2401-285	12 (300)	44 (1118)	32-1/2 (826)	3-1/2 (89)	55-5/8 (1413)	46 (1168)	61-9/16 (1564)	17-15/16 (456)	2.50 (395)	1.75 (276)	1.25 (197)
ALV3201-285	12 (300)	51-3/4 (1314)	41 (1041)	3-1/2 (89)	55-5/8 (1413)	46 (1168)	61-9/16 (1564)	17-15/16 (456)	3.09 (487)	2.16 (341)	1.54 (244)
ALV4001-285	12 (300)	59-3/4 (1518)	49 (1245)	3-1/2 (89)	55-5/8 (1413)	46 (1168)	61-9/16 (1564)	17-15/16 (456)	3.67 (579)	2.57 (405)	1.84 (290)
ALV1801-480	12 (300)	47-11/16 (1211)	27-1/2 (699)	14-3/8 (365)	63-1/8 (1603)	43-1/2 (1105)	62-3/4 (1597)	23-1/4 (591)	4.59 (725)	3.22 (507)	2.30 (362)
