Subject:	Geotechnical Report	
Tower Designation:	Tower Name:	Jemez Springs
Engineering Firm Designation:	SGS Towers Project Number:	2003830
Site Data:	1-329 Mooney Blvd., Jemez Springs, Ne Latitude 35.77154° Longitude -106.688 62 Foot Monopole Tower

*Sinnott Gering and Schmitt Towers, Inc.* is pleased to submit this "Geotechnical Report" to evaluate subsurface conditions in the area where the foundation is located. This report has been prepared in accordance with generally accepted geotechnical engineering practice for specific application to this project. While some transitions may be gradual, subsurface conditions in other areas may be quite different. Should actual site conditions vary from those presented in this report, SGS should be provided the opportunity to amend its recommendations as necessary.

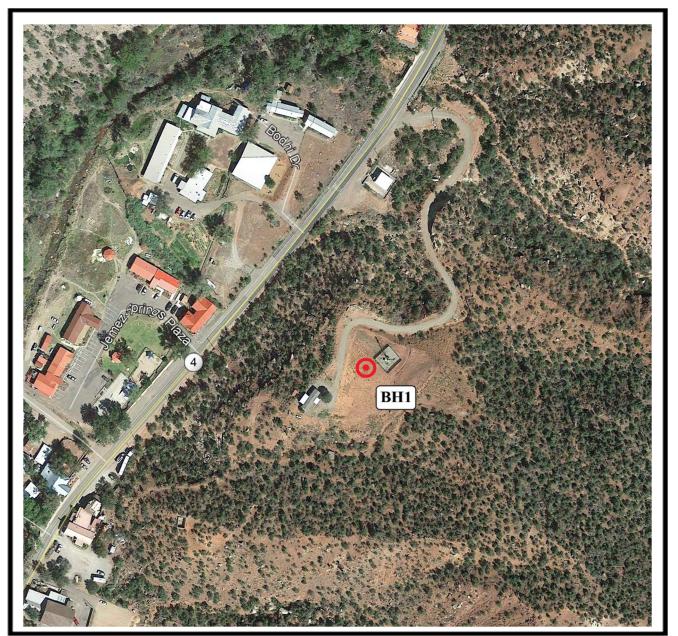
## Site Map

Located:	Jemez Springs, NM	Drilled By:	SGS	
Latitude:	35.77154°	Drill Date:	06/30/2020	
Longitude:	-106.68880°	Photo Date:	09/19/2017	VIV
Boring Location	n 💽		125 250	500

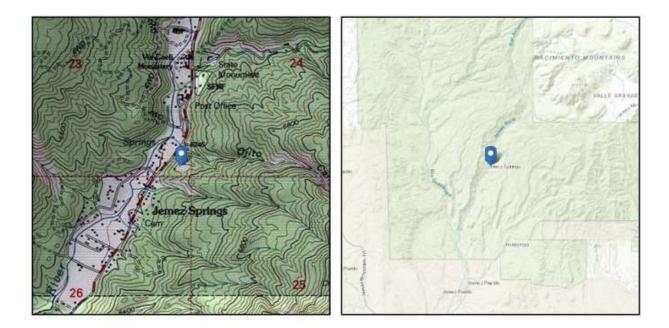
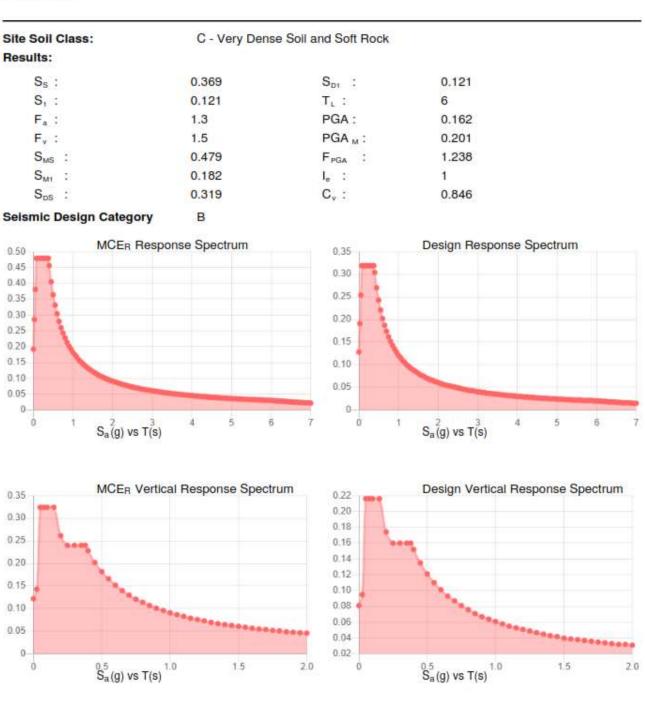
# ASCE 7 Hazards Report

Address: No Address at This Location Standard: ASCE/SEI 7-16 Risk Category: II Soil Class: C - Very Dense Soil and Soft Rock

Elevation: 6333.76 ft (NAVD 88) Latitude: 35.771536 Longitude: -106.688798
